Retrofitting of a Damaged School Building: A Case Study

Abstract— A three story damaged school building which has developed multiple cracks in floor slabs is investigated and analyzed. The building vertical load paths are determined and failure patterns studied. The retrofitting (strengthening) measures are worked out. The building is provided with suitable strengthening features to limit the damage and prevent future damages.

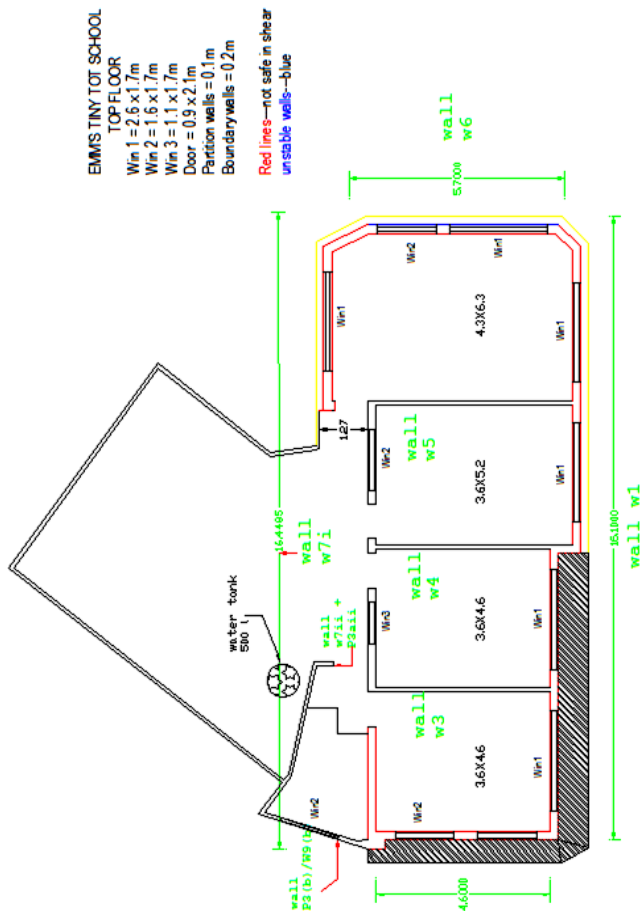
Fig. 1 Plan of Top Floor and Unstable Walls in Blue

in red in Fig. 1 for Top floor, are susceptible to such failure and walls in blue are unstable. Similar is the case depicted in Fig. 2 and 3. From above, it is found that only 7% of walls are unsafe for vertical and lateral loads; however, majority of them don't meet the earthquake considerations. Further, about 40% of walls in Top story are liable to shear failure.

C. Retrofitting- The walls that are not safe in shear are recommended to be provided with bands that give particular shear strength. This Lintel band is of dimensions 10cm depth x width 23cm x full length of wall is provided as per IS: 1905 in 15% of the walls as wall shear strengthener [5].

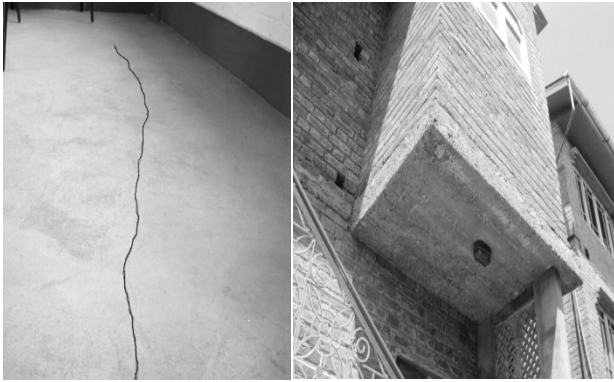
Fig. 4

A. Top floor plan of the load bearing masonry building is given in Fig. 1. Fig. 2 and Fig. 3 depict the first floor and ground floor respectively. The preliminary investigation states following problems: a. Slab cracks in Top and first Floor (Fig. 4a), b. some minor wall cracks. This is judged due to a. Probability of less reinforcement than required in slabs, b. Overhead projection without proper structural action (Fig. 4b). So the analysis is broken into wall analysis and slab analysis.

A. Cracks in Slab B. Overhead Projections

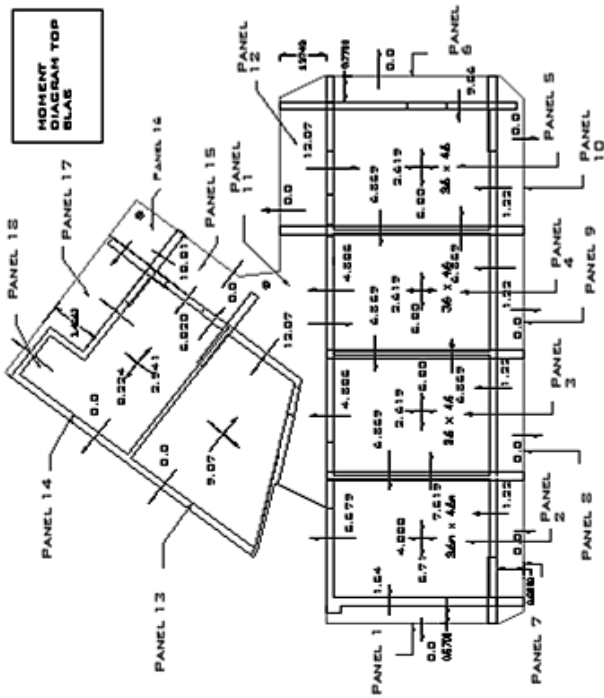
Fig. 5 Moments calculated by 'Yield Line Analysis' Top Slab

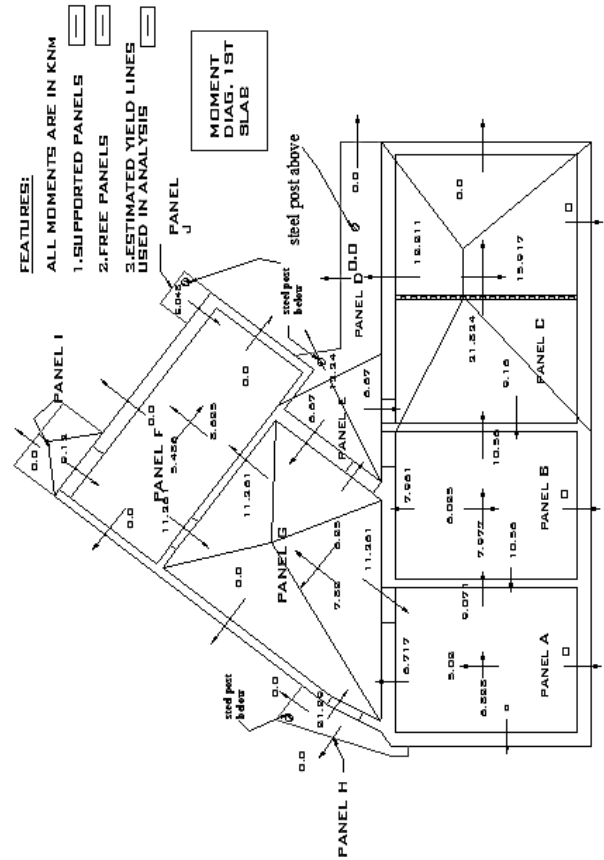
Fig. 6 Moments calculated by 'Yield Line Analysis' Bottom Slab

2. *Panel 'I' of First Slab* above ground floor has also developed torsional cracks as in Fig. 6 in previous page. On preliminary investigation, it is judged that this is due to excessive concentrated load. Moreover, on analysis, it is seen that there is not sufficient tensile reinforcement in either direction. The slab panel is cantilevered and reinforcement provided is less by 34% in one direction and 44% in other direction. Remedy suggested is a provision of two props at the extremities of the cantilever projection. These would ensure transfer of torsional moments and loads to the soil through a proper foundation. An I-Beam between the two props is also provided in order to transfer the slab load uniformly to the props. It is made composite with slab panel. After introduction of prop, the moments generated in slab panel are re-distributed and decreased. The existing reinforcement is enough to resist these re-distributed loads. So, there is no need of any further bottom reinforcement along any direction; as already compensated by distribution steel. Besides, there is no need for any additional top reinforcement along x-direction (Fig. 10). An I-beam ISLB-100 is provided to resist the loads acting on it. The prop provided is ISHT 200 and the base plate connection of beam with slab is a 450mm x 450mm x 30mm steel plate Fe415. Fig. 11 depicts the retrofitting of the Panel 'I'.

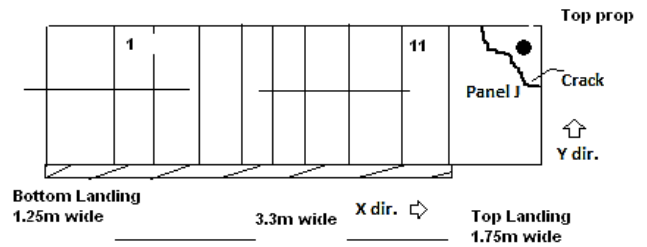
1. *Panel 'J' of First Slab* above ground floor has developed torsional cracks as in Fig. 6 in previous page. On preliminary investigation, it is judged that this is due to excessive unsymmetrical loading through a prop above the slab as shown in Fig. 7. The loading generated on the slab panel is shown in Fig. 8 below. It is found that the reinforcement provided is enough to support the panel, however there is eccentric load from above leading to torsion. Remedy suggested is a prop below at end of landing and provision of an angle section on two sides around the prop to a considerable distance, acting composite with the slab at the newly introduced slab. Due to this remedy, the moments in the slab are re-distributed by 5% leading to decrease in torsion of slab. Besides there is no need of any further bottom reinforcement along any direction; as already compensated by distribution steel. There is no need for any additional top reinforcement along x-direction (Fig. 7) as the moments are transferred to the composite angle sections provided. Also, there is no need for any additional top reinforcement along y-direction as moments is resisted well by the existing reinforcement. The prop is designed for base shear load of 107.38 KN and a rolled steel tube 'IS 200 Heavy' is provided. A base plate 450mm x 450mm x 30mm is provided after designing for a critical moment of 24838.04 N-mm. The complete retrofitting drawing of Panel J is shown in Fig. 9.

Fig. 7 Panel 'J' with Location of Prop and Cracking

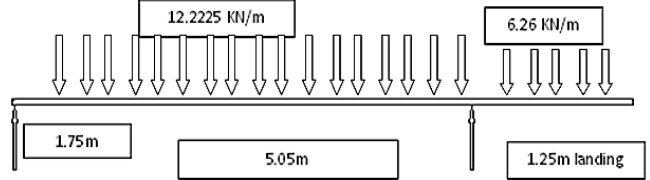
Fig. 8 Load Pattern on panel 'J'

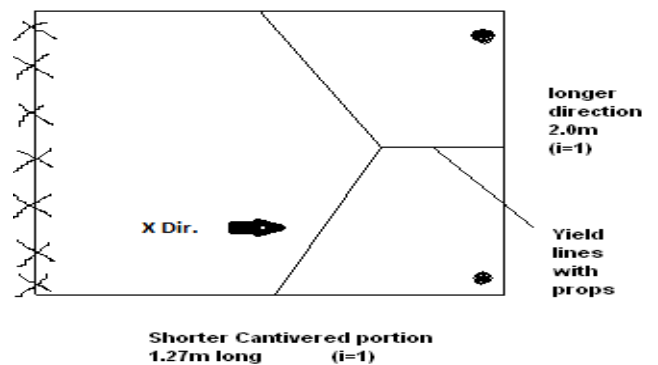
Fig. 10 Panel I with Yield Line Depiction for Props

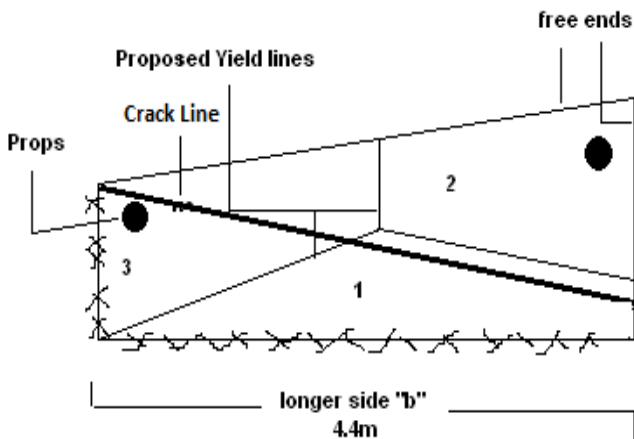
3. Panel 'H' of First Slab above ground floor has developed flexural cracks. Besides, by visual inspection it can be seen that there is excessive unsymmetrical concentrated load (Fig. 12). On analyzing, it was found that there is not enough tensile reinforcement to resist the flexural forces, which is short by 19% at critical location. Remedy is providing two props at the extremities of the cantilever projection. These would ensure transfer of torsional moments and a proper load transfer mechanism to through the foundation. Besides, an I-Beam along the longer dimension of the cantilever between the props which is made composite. On introduction of props, the moment resistance is re-distributed and decreased by 15% at the critical location. There is no need of any further bottom reinforcement along any direction; as already compensated by distribution steel. Besides, there is no need for any additional top reinforcement along shorter direction as moment to be resisted is by far less than moment resisted by reinforcement provided. However, props are required to transfer the torsional moments & concentrated loads. Further an I-Beam is required in order to transfer the loads uniformly as presumed in the yield line analysis. I-Beam ISMB 200 is provided and the props provided are ISHT 200 as shown in Fig. 13.

Fig. 12 Panel 'H' Crack and Yield lines
