# Retrofitting of a Damaged School Building: A Case Study

**Abstract**— A three story damaged school building which has developed multiple cracks in floor slabs is investigated and analyzed. The building vertical load paths are determined and failure patterns studied. The retrofitting (strengthening) measures are worked out. The building is provided with suitable strengthening features to limit the damage and prevent future damages.

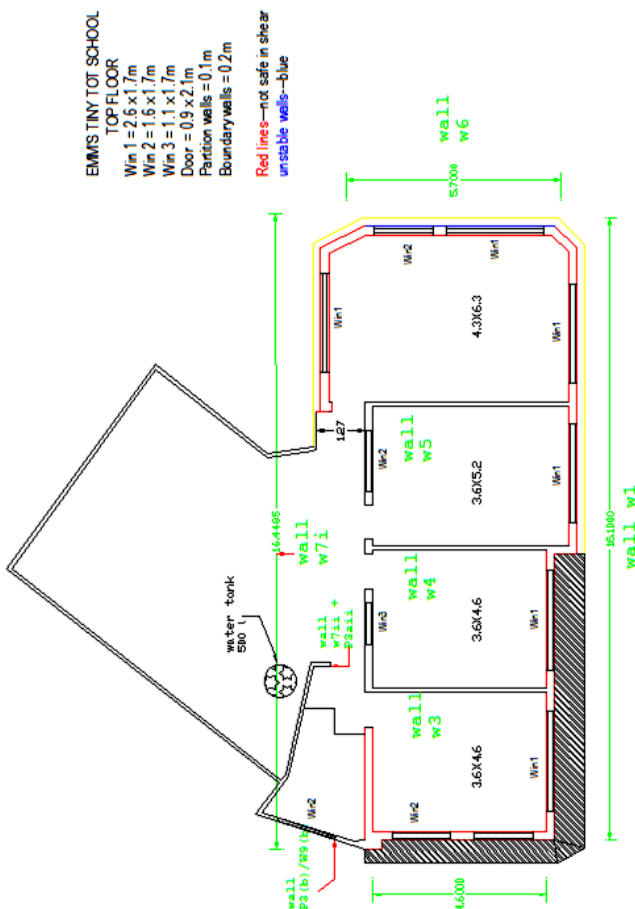
Fig. 1 Plan of Top Floor and Unstable Walls in Blue

in red in Fig. 1 for Top floor, are susceptible to such failure and walls in blue are unstable. Similar is the case depicted in Fig. 2 and 3. From above, it is found that only 7% of walls are unsafe for vertical and lateral loads; however, majority of them don't meet the earthquake considerations. Further, about 40% of walls in Top story are liable to shear failure.

C. Retrofitting- The walls that are not safe in shear are recommended to be provided with bands that give particular shear strength. This Lintel band is of dimensions 10cm depth x width 23cm x full length of wall is provided as per IS: 1905 in 15% of the walls as wall shear strengthener [5].

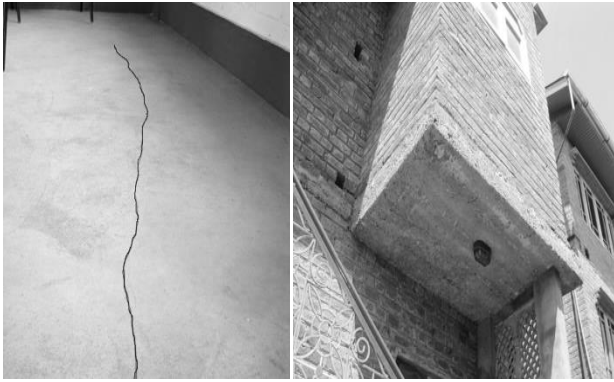
Fig. 4

A. Top floor plan of the load bearing masonry building is given in Fig. 1. Fig. 2 and Fig. 3 depict the first floor and ground floor respectively. The preliminary investigation states following problems: a. Slab cracks in Top and first Floor (Fig. 4a), b. some minor wall cracks. This is judged due to a. Probability of less reinforcement than required in slabs, b. Overhead projection without proper structural action (Fig. 4b). So the analysis is broken into wall analysis and slab analysis.

A. Cracks in Slab      B. Overhead Projections

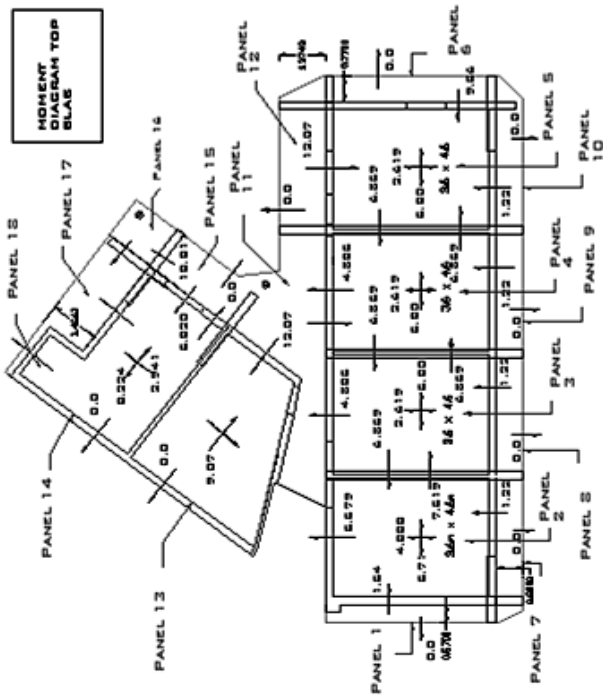
Fig. 5 Moments calculated by 'Yield Line Analysis' Top Slab

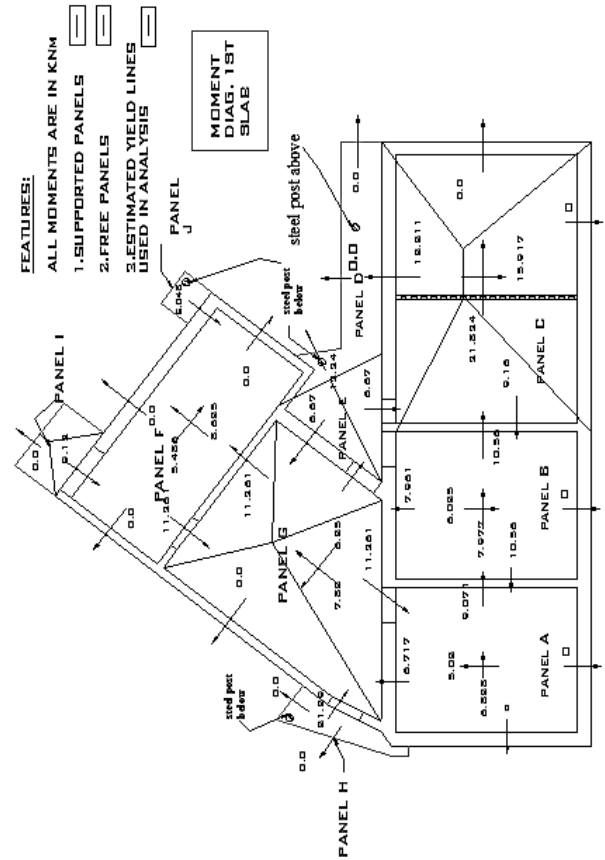
Fig. 6 Moments calculated by 'Yield Line Analysis' Bottom Slab

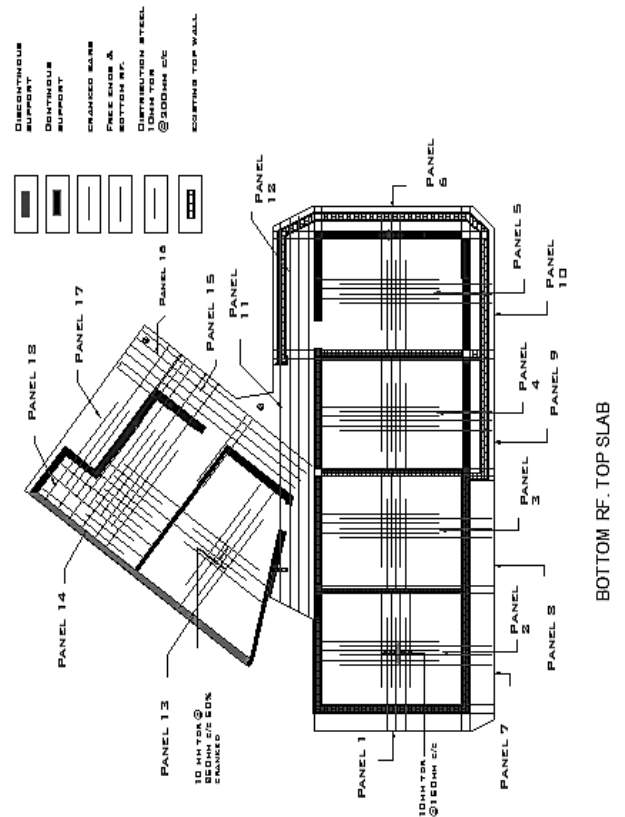
B. The slab analysis is performed by breaking the slabs into individual panels and implementing yield lines [4]. For each panel, the loaded moments are calculated (Fig. 5 and Fig. 6) and reinforcement required is determined. The reinforcement provided is checked by bar detector (Fig. 7). Thereby flexural check is performed. Besides, the shear check and deflection check is performed to gain additional information. For top slab given in Fig. 5, the panel 6 is failing in flexure while as for first slab given in Fig. 6, panel H, I, J are failing in flexure and shear after check. It is seen that overall bearing strength of soil is less than  $50T/m^2$  and is safe in bearing strength.

Fig. 7 Bottom Reinforcement Provided in Top Floor Slab

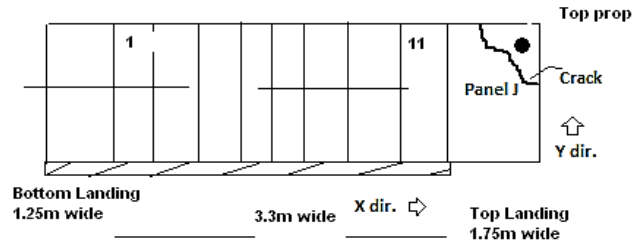
1. *Panel 'J' of First Slab* above ground floor has developed torsional cracks as in Fig. 6 in previous page. On preliminary investigation, it is judged that this is due to excessive unsymmetrical loading through a prop above the slab as shown in Fig. 7. The loading generated on the slab panel is shown in Fig. 8 below. It is found that the reinforcement provided is enough to support the panel, however there is eccentric load from above leading to torsion. Remedy suggested is a prop below at end of landing and provision of an angle section on two sides around the prop to a considerable distance, acting composite with the slab at the newly introduced slab. Due to this remedy, the moments in the slab are re-distributed by 5% leading to decrease in torsion of slab. Besides there is no need of any further bottom reinforcement along any direction; as already compensated by distribution steel. There is no need for any additional top reinforcement along x-direction (Fig. 7) as the moments are transferred to the composite angle sections provided. Also, there is no need for any additional top reinforcement along y-direction as moments is resisted well by the existing reinforcement. The prop is designed for base shear load of 107.38 KN and a rolled steel tube 'IS 200 Heavy' is provided. A base plate 450mm x 450mm x 30mm is provided after designing for a critical moment of 24838.04 N-mm. The complete retrofitting drawing of Panel J is shown in Fig. 9.

Fig. 7 Panel 'J' with Location of Prop and Cracking

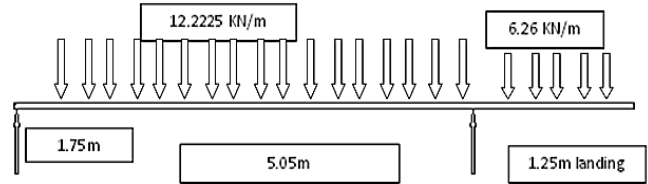
Fig. 8 Load Pattern on panel 'J'

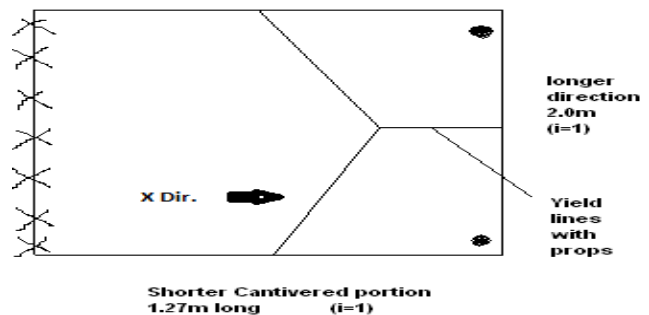
2. *Panel 'I' of First Slab* above ground floor has also developed torsional cracks as in Fig. 6 in previous page. On preliminary investigation, it is judged that this is due to excessive concentrated load. Moreover, on analysis, it is seen that there is not sufficient tensile reinforcement in either direction. The slab panel is cantilevered and reinforcement provided is less by 34% in one direction and 44% in other direction. Remedy suggested is a provision of two props at the extremities of the cantilever projection. These would ensure transfer of torsional moments and loads to the soil through a proper foundation. An I-Beam between the two props is also provided in order to transfer the slab load uniformly to the props. It is made composite with slab panel. After introduction of prop, the moments generated in slab panel are re-distributed and decreased. The existing reinforcement is enough to resist these re-distributed loads. So, there is no need of any further bottom reinforcement along any direction; as already compensated by distribution steel. Besides, there is no need for any additional top reinforcement along x-direction (Fig. 10). An I-beam ISLB-100 is provided to resist the loads acting on it. The prop provided is ISHT 200 and the base plate connection of beam with slab is a 450mm x 450mm x 30mm steel plate Fe415. Fig. 11 depicts the retrofitting of the Panel 'I'.

Fig. 10 Panel I with Yield Line Depiction for Props

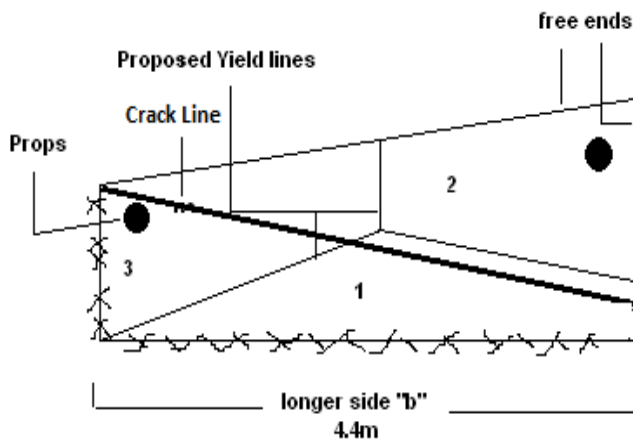
3. Panel 'H' of First Slab above ground floor has developed flexural cracks. Besides, by visual inspection it can be seen that there is excessive unsymmetrical concentrated load (Fig. 12). On analyzing, it was found that there is not enough tensile reinforcement to resist the flexural forces, which is short by 19% at critical location. Remedy is providing two props at the extremities of the cantilever projection. These would ensure transfer of torsional moments and a proper load transfer mechanism to through the foundation. Besides, an I-Beam along the longer dimension of the cantilever between the props which is made composite. On introduction of props, the moment resistance is re-distributed and decreased by 15% at the critical location. There is no need of any further bottom reinforcement along any direction; as already compensated by distribution steel. Besides, there is no need for any additional top reinforcement along shorter direction as moment to be resisted is by far less than moment resisted by reinforcement provided. However, props are required to transfer the torsional moments & concentrated loads. Further an I-Beam is required in order to transfer the loads uniformly as presumed in the yield line analysis. I-Beam ISMB 200 is provided and the props provided are ISHT 200 as shown in Fig. 13.

Fig. 12 Panel 'H' Crack and Yield lines
