Discontinuity Mapping using Terrestrial Laser Scanner and Kinematic Method

Rasyikin Roslan, Rohayu Che Omar, Intan Nor Zuliana Baharuddin, Warishah Abdul Wahab,
Faten Syaira Buslima

The purpose of this study is to provide the current site and slope condition of comprehensive geological study using terrestrial laser scanning and discontinuity survey at Simpang Pulai, Perak.

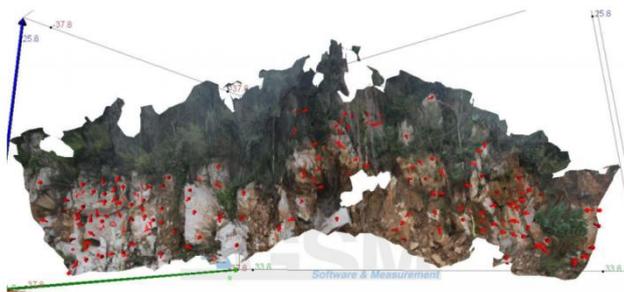
Fig. 4 3D image for Area 1

Fig. 4. Red arrows show the direction of the discontinuity. The kinematic analysis for Area 1 is shown in Fig. 5. There are ten (10) sets of major discontinuities with slope face ($145^{\circ}/62^{\circ}$) in Area 1.

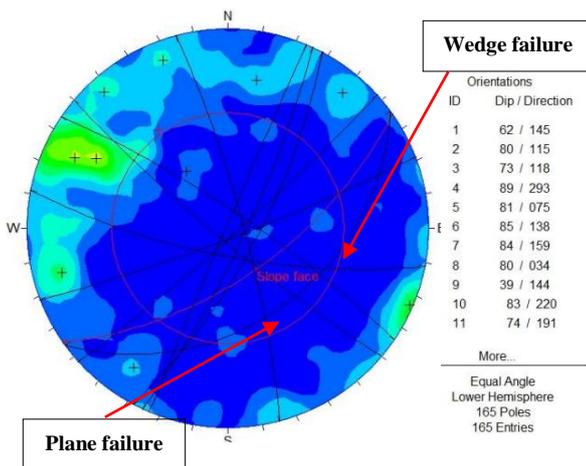
Fig. 5 Kinematic analysis for Area 1

From Fig. 5, it can be seen that there are 165 readings of discontinuity surveys along this area. The potential failures in this area are plane and wedge failures.

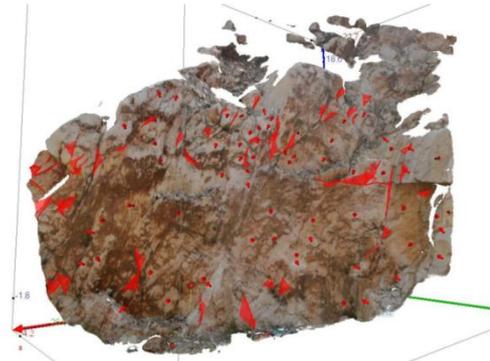
Fig. 6 3D image of Area 2

The 3D image for Area 2 is shown in Fig. 6. In this area, there are eight (8) sets of major discontinuities with slope face ($035^{\circ}/70^{\circ}$) were identified as shown in Fig. 7.

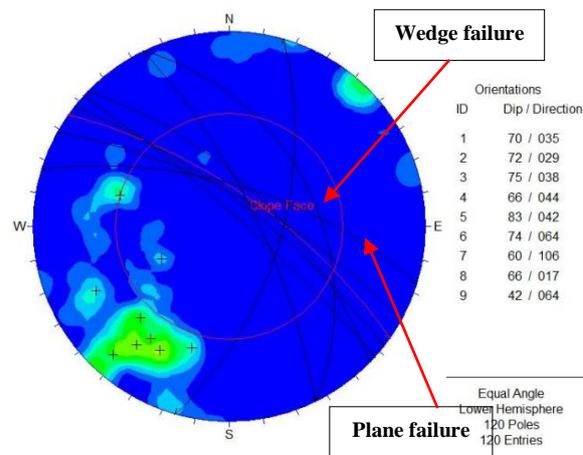
Fig. 7 Kinematic analysis for Area 2

Fig. 7 shows the kinematic analysis for Area 2. This analysis came from 120 readings of the discontinuity survey along this area. There are two potential failures identified in this area which are plane and wedge failures.

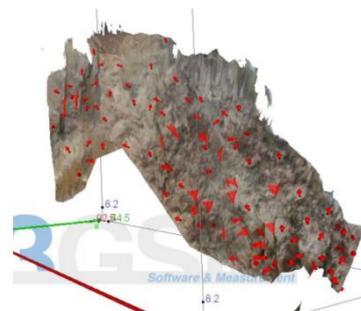
Fig. 8 3D image of Area 3

In Area 3, as shown in Fig. 8, there are five (5) sets of major discontinuities with slope face ($146^{\circ}/55^{\circ}$) were identified. This result came from 100 readings of discontinuity survey along this area as shown in Fig. 9.

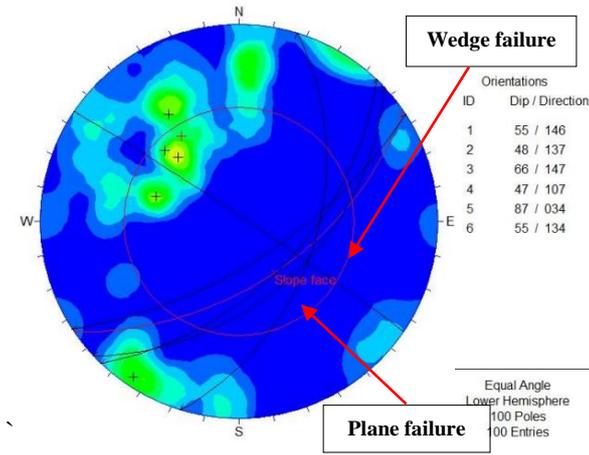
Fig. 9 Kinematic analysis for Area 3

Fig. 9 shows the results of the kinematic analysis for Area 3. In this area, the potential failures that have been identified are plane and wedge failures.

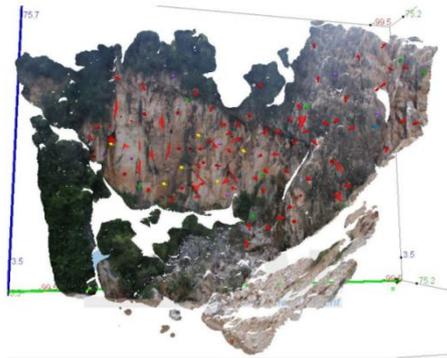
Fig. 10 3D image of Area 4

As shown in Fig. 10, there are five (5) sets of major discontinuities with slope face (107°/52°) in Area 5. The red, yellow and green arrows differentiate the direction of discontinuities in Area 4.

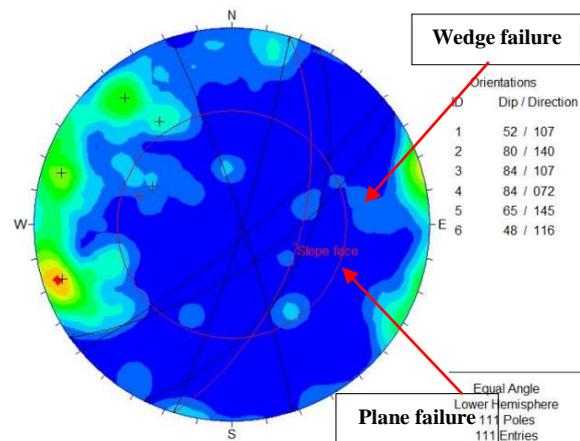
Fig. 11 Kinematic analysis for Area 4

Fig. 11 shows the kinematic analysis results for Area 4. These results came from 111 readings of the discontinuity survey along this area. Based on the results, it can be seen that the potential failures in this section are plane and wedge failures.

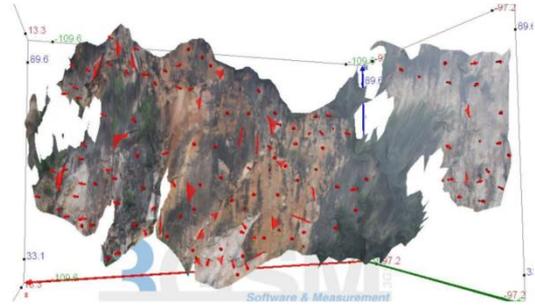
Fig. 12 3D image of Area 5

There are seven (7) sets of major discontinuities with slope face (022°/77°) at Area 6 as shown in Fig. 12. The results came from 141 readings of discontinuity survey along this area as stated in Fig. 13.

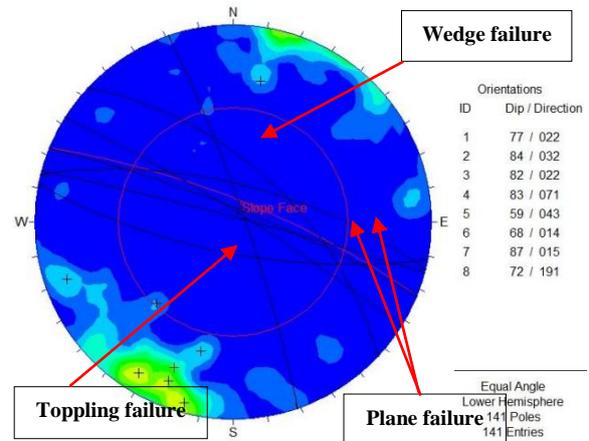
Fig. 13 Kinematic analysis for Area 5

Kinematic analysis for Area 5 is shown in Fig. 13. Based on the figure, three types of potential failures were identified in this area which is plane, wedge and toppling failures.

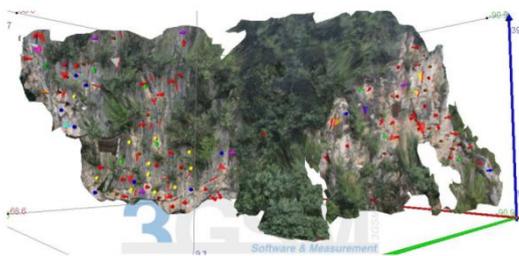
Fig. 14 3D image of Area 6

In Area 6, as shown in Fig. 14, there are eight (8) sets of major discontinuities with slope face (298°/77°) that were detected based on 139 readings of discontinuity survey along this area.

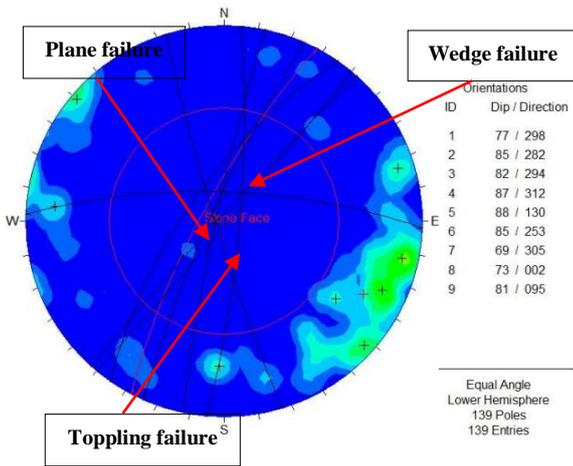
Fig. 15 Kinematic analysis for Area 6

Fig. 15 represents the kinematic analysis results for Area 6. The potential failures that were identified in this section are plane, wedge and toppling failures.
