Failure Analysis of the Furnace Scotch Boiler

Desiran Sembiring, Djoko Setyo Widodo, Bintang Adjiantoro, AB Saman, Bin ABD Kader

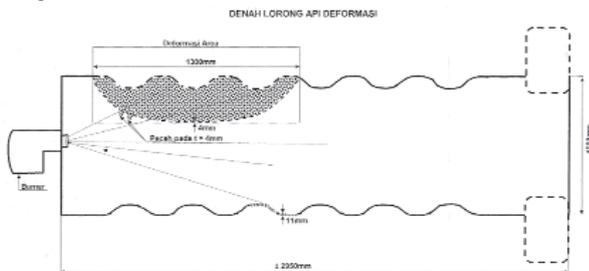
Figure 4. Position of the cross-section of furnace that has been damaged

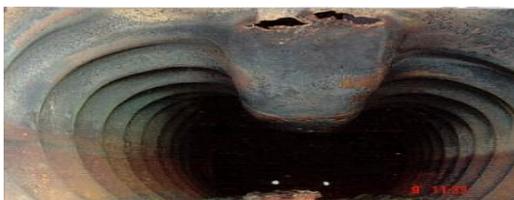
Figure 5.

Visually inspect the exact position of entry of boiler fill water and macrograph on the surface of the furnace of Scotch boiler in the right position of the water filler shows a rupture of 20cm (Figure 5).

The furnace wall which is bumpy at the top occurs plastic and ruptured deformation. Right at the diameter limit upwards which is blue, indicating identification at high temperatures.

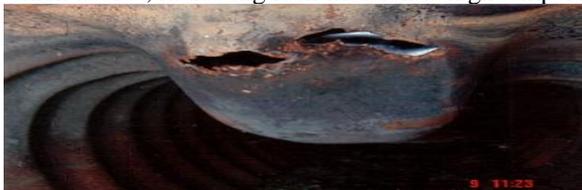
Figure 6.

A furnace is ruptured, so that the water steam pressure and water emanating from this hole precisely leads to the burner's mouth.

The rupture is indicated by the pressure/force of very high water steam which is sufficient to transform the cylindrical waves and push inward until the furnace experiences bulging in areas that have decreased strength due to high

concentrations of heat (> the temperature of the annealing material) resulting in sufficient plastic deformation high.

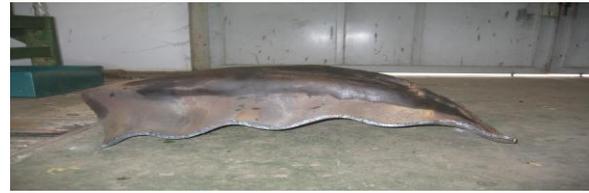
Figure 7. Fractography of a piece of a furnace at the upper fireside (side view)

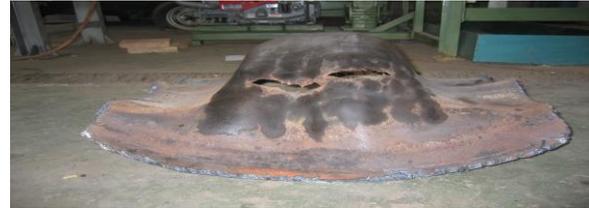
Figure 8. Fractography of a piece of a furnace at the upper fireside (front view)

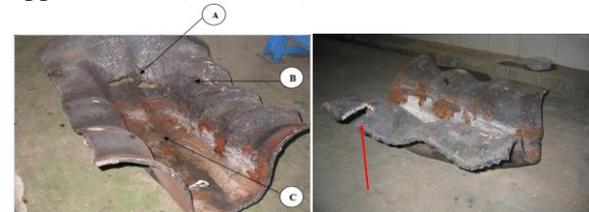
Figure 9. Furnace - the upper waterside that has failed, shows a change in shape (plastic deformation). A, B and C are the test sample areas.

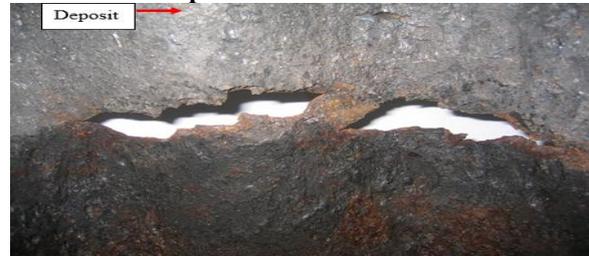
Figure 10. Fractography of the furnace wall - the upper waterside at Location A

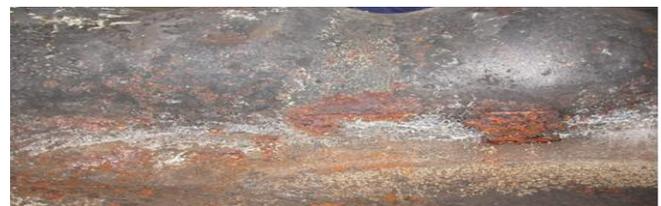
Figure 11. Fractography of a furnace - the upper waterside at Location B

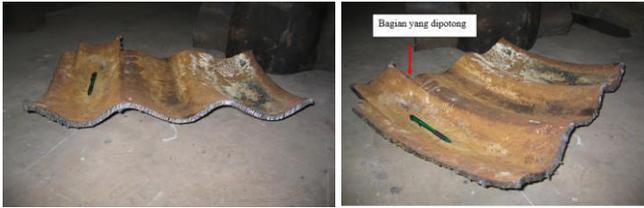
Figure 12. Fractography of the furnace - the bottom fireside that is not subjected to plastic deformation.

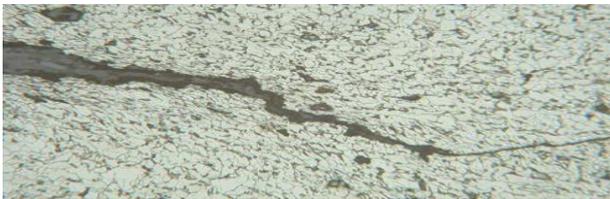
Examination of the microstructure carried out on the furnace shows the presence of creeping cracks (Figure 13). Cracks propagating in the form of cracks at the grain boundary (intergranular) which contain corrosion products which are indicated to originate from fuel dust (Figure 14). Corrosion products are reinforced by evidence of the EDS analysis results in Table 6.

Figure 13. Microstructure in the fracture area which has a ferrite-pearlite phase. 500x

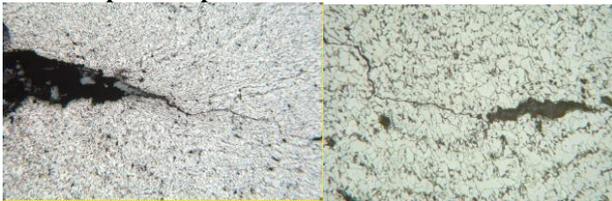
Figure 14. The microstructure of crack tip that occurs on the furnace wall, showing intergranular cracks of 200x Etch: Nital 2%.

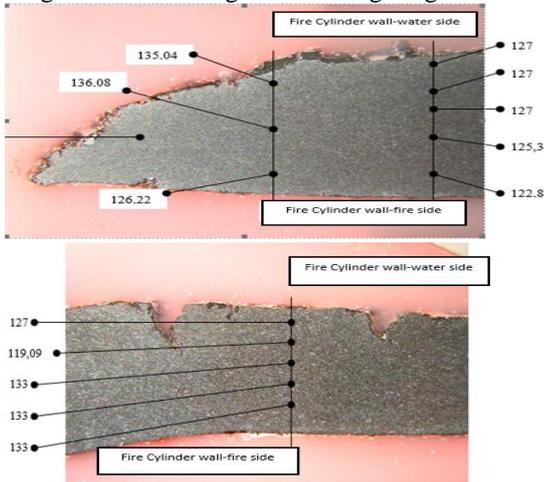
Testing the hardness of the ruptured furnace is carried out to determine the change in hardness. From the results of the hardness test in both samples, it showed that the average hardness value of the ruptured furnace material was 136 VHN and 122 VHN, respectively. Data from the results of hardness testing are shown in Figure 15 through Figure 17.

Figure 15. The deformed hardness of the furnace wall forming bulging and ruptured (sample pieces A)

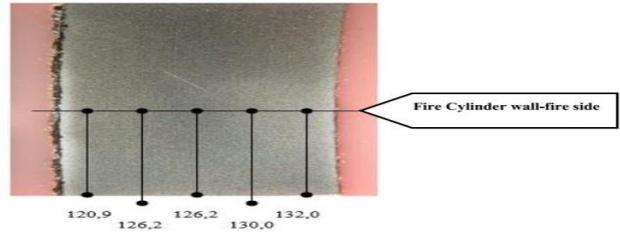
Figure 16. The hardness of the furnace wall closer to the occurrence of deformation (cut of sample B)

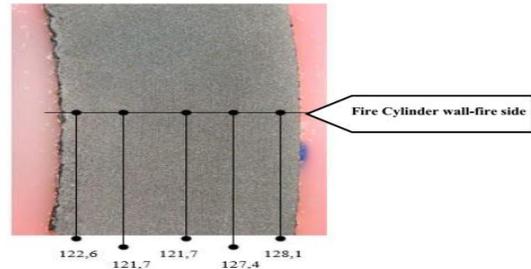
Figure 17. The deformed hardness of the furnace wall forming a curve (cut of sample C)

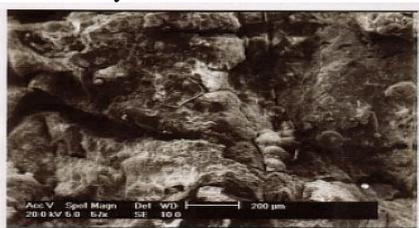
The results of examination with SEM and EDS on the surface of the furnace in a ruptured position, can be seen in Figure 18 and Table 6. Appearance on the surface of waterside of the furnace is a corrosion product in the form of a deposit. In the furnace the leaky side of the fire leaked detected elements such as carbon (C), silicon (Si), sulfur (S), potassium (K), and calcium (Ca) indicated by fuel.

Figure 18. SEM surface micrography of the deposit on the waterside of the furnace that has ruptured

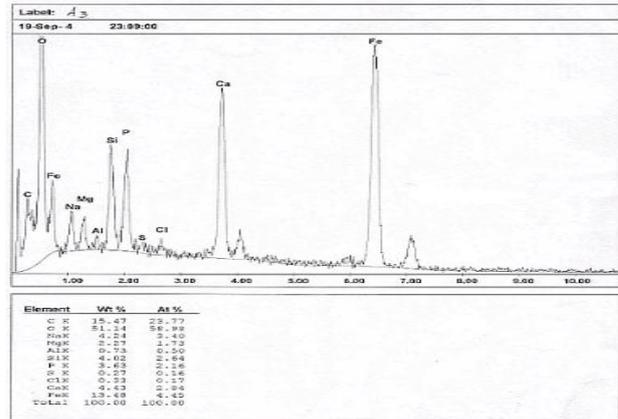
Figure 19. Analysis of the composition of the SEM-EDS deposit on the waterside of the furnace wall that has ruptured

The substances contained in large percentages in the crust include iron (13.48%), magnesium (2.27%) and sodium (4.24%) and chloride (0.33%). These last two elements can be corrosive to the steel furnace material of the steam boiler concerned.
