Shaft Failure Sea Water Pumps At the Steam Power Plant Units

Djoko Setyo Widodo, Desiran Sembiring, Bintang Adjiantoro, AB Saman
Bin ABD Kader

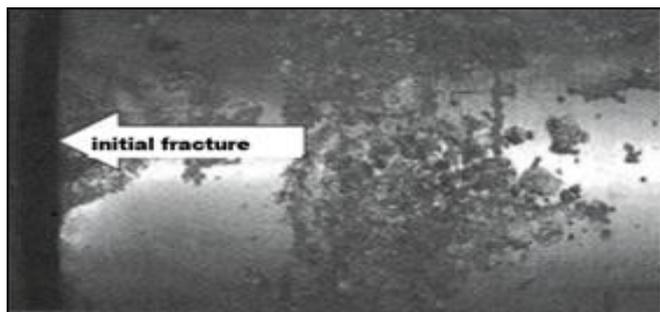
Figure 3. Center of Initial Fracture on Shaft outside Section

Visual inspection includes taking pictures directly on the bottom shaft that has a fracture. The shooting location is in the cross-section of the fracture and the outer area around the beginning of the fracture. In Figure 3 we can see the damage experienced by the shaft. In the outer area of the shaft, there is pitting corrosion near the beginning of the fracture. Damage is not very clearly seen in the cross-section of the fracture because it is slightly damaged due to the impact and corrosion of the surface, but the beginning of the fracture and the final fracture is still apparent. The cross-section of the shaft

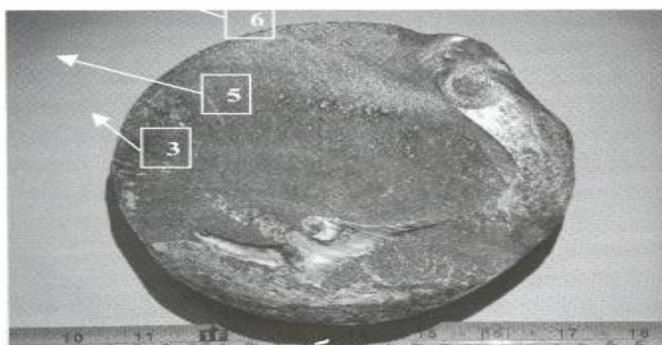
Figure 4. Position of Observation of Macro Structures

fracture will be clarified in fractographic testing. Figure 4 shows a cross-section of the fractured shaft.

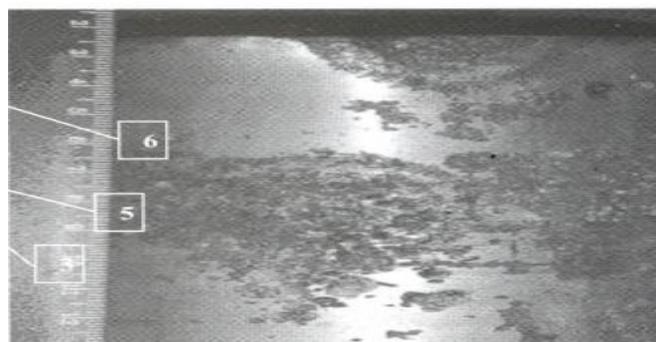
Figure 5. Position of Micro Structural Sampling at the Beginning of the Shaft Cross Section

In Figure 5, there is a corrosion attack on the outer cross-section of the shaft which is far from the beginning of the fracture. This shows that the pump shaft has been attacked by a lot of corrosion. From the observations in Figure 5, it also appears that the most corrosion occurs in the initial area of the fracture.

The initial area of the crack marked with an arrow indicates a centered marking that has spread and has spread into the center of the shaft. The sign is not clear because the initial crack has been damaged due to being hit and scratched during the release process. This area is located on the shaft surface which is affected by pitting corrosion which has spread into the shaft causing a high-stress concentration.

The occurrence of pitting corrosion attacks is estimated to be caused by inundated seawater at the start of the installation of the pump. During installation, the pump is not directly in use and while waiting for the operating, the shaft is flooded by the seawater. Another possible cause is the presence of chloride (Cl) in seawater.
