# Failure Characteristics on ADNAN (Malaysian Armoured-Vehicle) Track Shoe and its Improvements

Muhamad Hellmy Hussin, NurAzida CheLah, Shamsul AkmarAbd. Aziz

### C. ADNAN Malaysian Armoured Vehicle Track Shoe

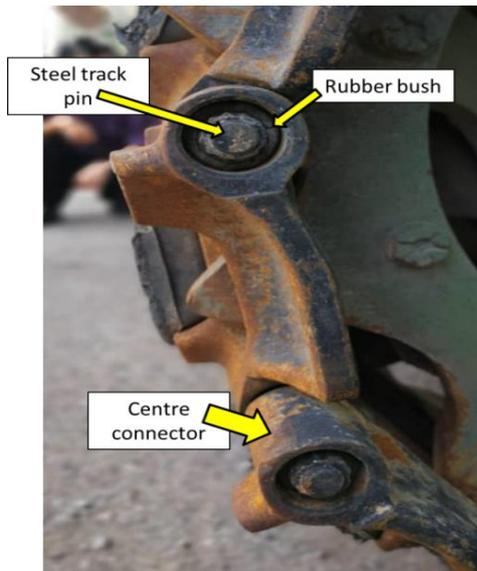
**Fig. 4. Track pin ADNAN – Malaysian Armoured Vehicle**

Fig. 4 presents a typical pin which consists of circular steel rod and the rubberised bushes. It is embedded on the steel pin with intervals between the bushes. The same procedure experienced by other armoured vehicles also applied to ADNAN where the pin is inserted into the block holes. When the insertion of pin begins, the bush was found having compression stress. As consequences, the rubber fills these intervals and was found to transform into a full cylindrical shape. When ADNAN is in operations and manoeuvred by personnel, the relative movement between the blocks is accommodated by twisting the rubber bush. The most common failure factor is mainly dependent on the rubber

bush.

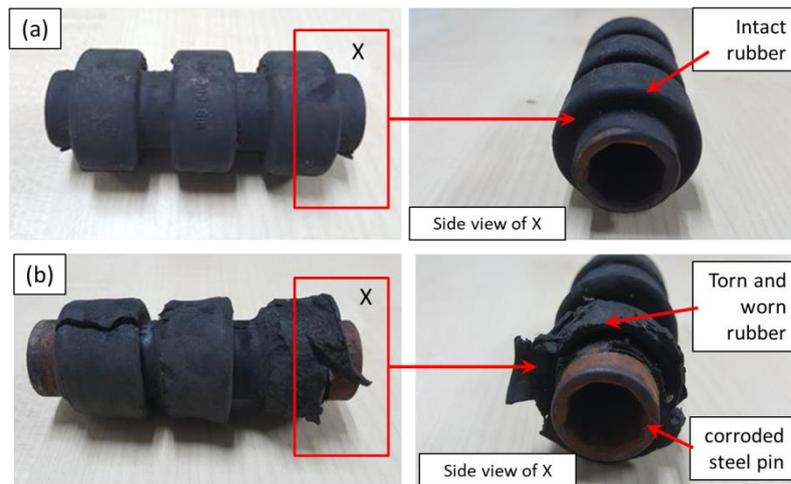
As indicated in Fig. 5, one of the parts of rubber bush was worn and torn due to the filling of rubber into the block. In Fig. 5 (a) the rubber in this bushing looks almost new. The rubber bush has failed in a relatively small area in a purely radial direction (Fig. 5(b)). It shows that the bush has a crushed zone and a torsional tearing around the circumference of the pin. Rust is also seen on the sample due to the migration of water into the connector bore as the bushings failed [4]. From observation, it was found that the life of rubber bush is dependent on the stresses during filling process, subjected to external load due to track tension. It is also possibly due to the shear load resulting from the relative movement of the blocks and the temperature rise due to the hysteresis of these loads. In this case, it was possibly observed that the rubber bush was subjected to hysteresis friction that is caused by the energy dissipation due to internal material damping during the deformation process [1,14]. The deformed part occurs during the sliding of a rubber element across the rough surface.

During the insertion process of bushes into the track block, they elongate in the axial direction till two adjacent bushes get in touch with each other. As the insertion applied and since the rubber behaves as an incompressible material, this process continued until the surface of the rubber bush are in contact with the surface of steel connector and pin side wall respectively as shown in Fig. 5.

of the connector bore and pin were coated with rust as indicated in Fig. 5(b). The rusted area was found on the inner and outer pin surface due to uniform corrosion. As well known, the rust has a rough corroded surface and this would become one of the factors that could damage and deteriorate the rubber surface. When the counter surface of rubber bush is repeatedly deformed, this could leads to energy loss due to the internal friction or also known as hysteresis of the rubber. As consequences, the energy transformed into the heat and continuously supplemented if the sliding speed is intended to be constant [1].

In Stage II as shown in Fig. 5, as the rubber surface slides repeatedly, instead of friction, abrasion could also be one of the effects that worn the rubber bush surface [22]. In this case, abrasive wear can be defined as the removal of material due to penetration of hard particles or surface asperities of the harder steel surface into the softer surface during solid sliding contact [23]. As the sliding force continues, the abrasion and friction caused the removal of rubber particles filled the space area between the spin and inner connector bore surfaces. The rubber particles which were chipped by abrasive wear will act as the stress concentrator factor that may end in a great number of surface damage. Prolonged cyclic stresses of loading and unloading during rubber bush insertion together with sliding and rolling of rubber particles caused the shear and fatigue stresses to occur as indicated in Stage III. Thus, would leads to the deterioration of rubber bush.

Fig. 5. Rubber bushing failure, (a) intact rubber, and (b) torn and worn rubber

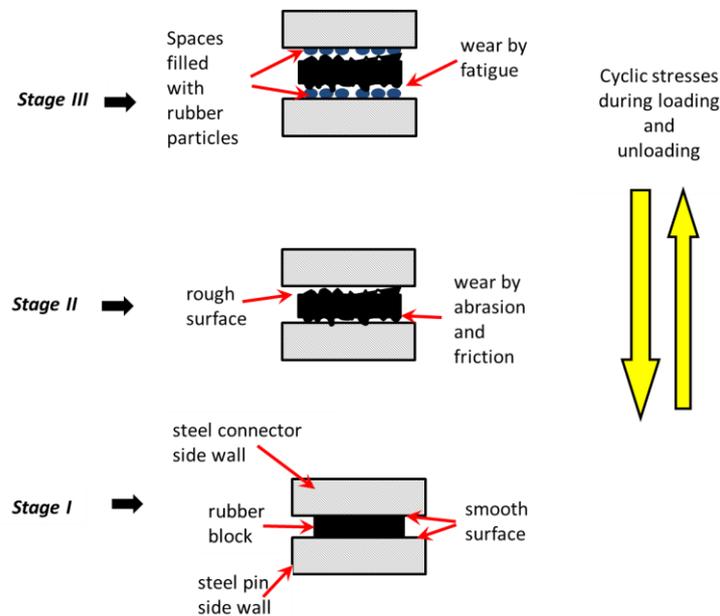
As depicted in Fig. 6, the proposed rubber bush wear failure mechanism between the outer surface of the rubber and inner bore of the block surface is identified. The proposed mechanism is divided into three stages which are stage I, II and III. According to the stage I, the inside surface of the rubber bush is in contact with the rigid steel pin and connector side wall and it can be said that the displacement of both surface area are restrained. As proposed in stage I, it shows that both side walls which is in contact with the rubber bush shows a smooth counter face surface. This possibly because of the inner layer of the rubber bush is rigidly fixed. Although it is fixed, some problems could occur and one possible deformation is distortion.

During the insertion of rubber bush, when rigidity becomes an important factor to make sure the rubber bush is fixed, the rubber surface could possibly distort. This makes the outer face of the bush is allowed to slide. As indicated in Stage II, where both fixed and rigid steel connector and pin side wall are in contact with each other, mainly at the area between the rubber and the counter surface, friction could possibly be the cause of the failure. Friction is one of the failure mechanism which is due to two physical phenomena which are (i) adhesion between the surfaces and (ii) hysteresis loss in rubber [13]. In this case, as the rubber bush slides repeatedly on the side wall counter surface which is rigid compared to rubber, and through time the surface of the steel could deform the rubber surface. It is getting worst if both counter surface

Instead of insertion of rubber bush process, the other aspects that need to take into account is the deformation that occur resulting from plain sliding of bushings and pins during service and for instance, when the rubber bush worn and torn due to the rubber deformation as indicated in Stage III (Fig. 6). The illustration of point enlargement of Stage III is depicted in Fig. 7. As well known, armour tank is categorized under heavy machinery that operates in various loads and speeds. At high loads and low speeds, the pins and bushings operate in the regime of boundary lubrication. In this case, when the rubber bush deteriorated, the counter surface of steel pin and connector bore side wall were in rigid contact. At this particular case, the contact stresses were developed due to the connection movement between pins and bushings or also with side wall of the connector bore. This movement allows the rotation of the pin and sliding movement of the bushing which is in contact with internal side wall of connector bore. It is possible to suggest that under such condition, where the deterioration of rubber bush was significant and lack of lubrication between the contacts of similar metals, this condition is prone to the galling failure [3].

Fig. 6. Illustration of rubber bush wear failure mechanism

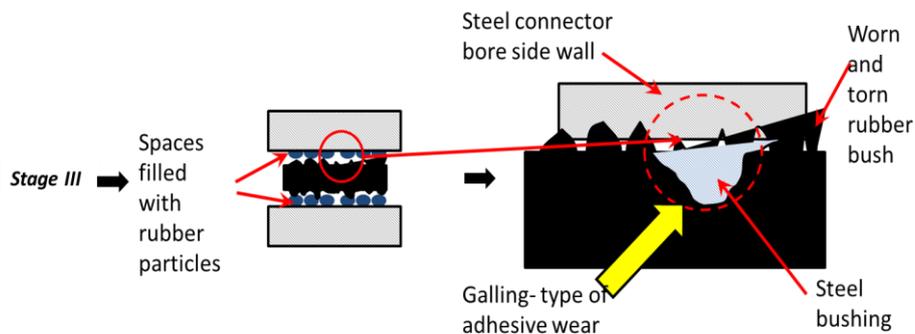
Galling is one type of abrasive wear that caused by adhesion between sliding surfaces. This type of wear failure is caused by a combination of friction and adhesion between the metal surfaces, followed by slipping and tearing of crystal structure beneath the surface. According to the Fig. 7, it is possible to note that the major reason for the loss of oil or lubrication in the pin and bushing is the wear of rubber or any other seal type.

As the rubber bush or seal damaged and deteriorated by abrasives the seizure contact between both metal side walls caused a press-fit condition. The rubber particles or wear

debris was found to decrease the clearance between both side walls.

Fig. 7. Illustration of point enlargement of galling wear mechanism of steel connector and bushing side wall

Thus, eventually creates high contact stresses and as the cyclic stresses continues, it's finally creates wear damaged and susceptible for crack to initiate.
