Reliability of Thin (Metal) Film Resistors

Impact of Pulse Screening

Abhijit D. Rane, Venkat N. Ghodke

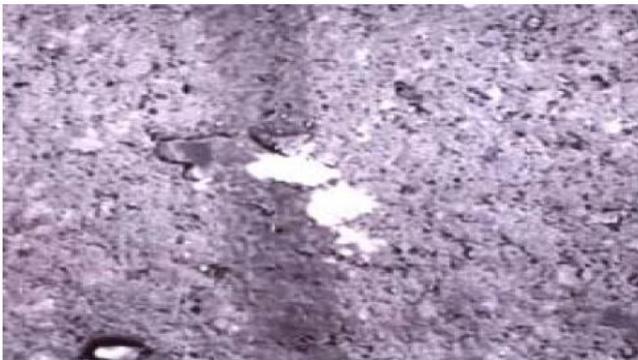
Fig. 5: Strange Materials (in this Case Brass Flakes) in Trim Cut Lower Isolation Distance

Figures 5 and 6 show latent shorts caused by different strange materials. At the release test in factory, components have shown correct resistive values. But after harsh pulse loading the limited isolation distance in trim track leads to material migration due to electric field strength, which leads finally to the bridging and shorting of trim helix.

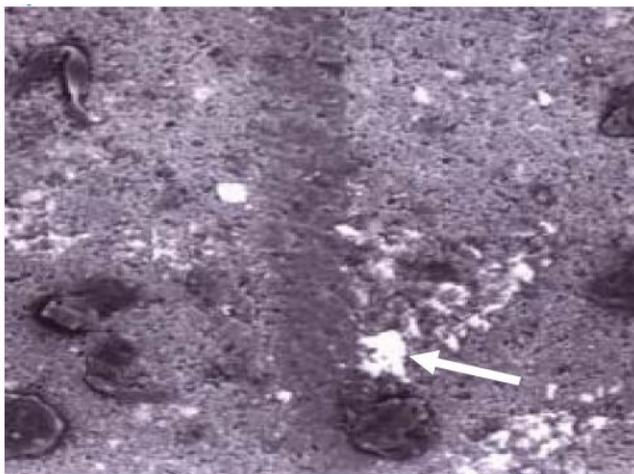
Fig. 6: Iron Containing Abrasion on Resistor's Surface (Bright Zones) Due to Attrition during Machining Have Narrowed the Isolation Distance of Trim Kerf
