# Seismic Protection of Non-Engineered Building in North East India

**Abstract—** Northeast India is regarded as one of the most seismically active regions worldwide. Moreover, rapid urbanization in the region have provided a higher level of man-made constructions deviating from the typical traditional houses to multistoried structures but most of these structures are non engineered construction. Even though engineered, more emphasis is given to architectural concept than the structural design, which is indeed very important. So the implementation of earthquake resistant building design and construction code at the local level has been more of an exception than the rule, thereby implicating increased vulnerability to earthquake disasters. That's why there is a need for the construction of a simple construction practices for use by the community. This paper deals with the different types of non engineering building construction that are practiced in Northeast India and the ways for strengthening these building to make them a low cost earthquake resistant building.

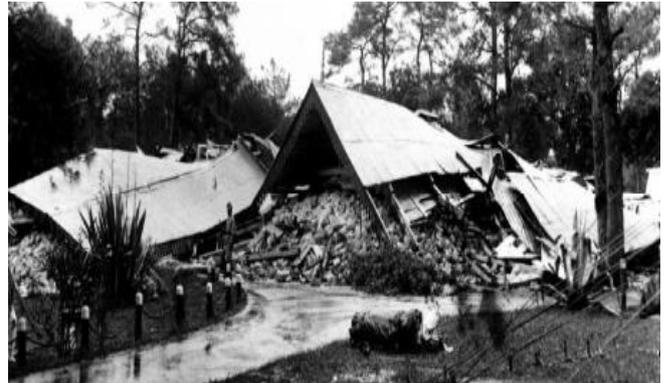
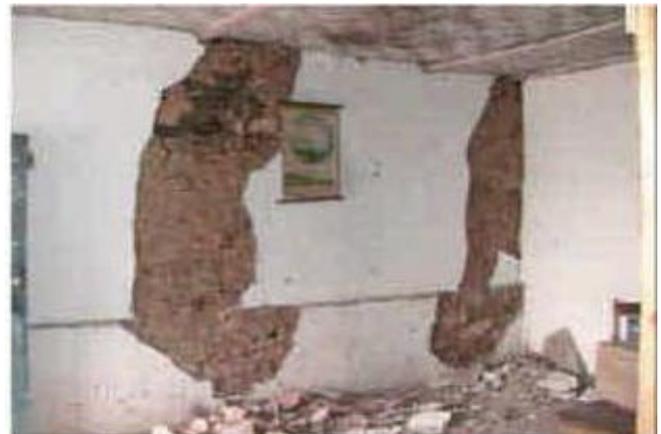
Fig.1 Damages of Non-Engineered Houses

(a) The European Quarters in 1897 Shillong earthquake

(b) Severely damaged stone masonry low-cost school buildings in 2006 Sikkim Earthquake

Northeastern Region of India is prone to natural disasters like Earthquake. The region has experienced 18 large earthquakes ( $M > 7$ ) during the last hundred years including the great earthquakes of Shillong (1897,  $M = 8.7$ ) and Assam-Tibet border (1950,  $M = 8.7$ ) (Tiwari 2002). At the latest, Sikkim earthquake of 18<sup>th</sup> September, 2011 ( $M = 6.9$ ) caused severe destruction of properties and loss of lives. Besides, several hundred small and micro earthquakes have also been recorded. The past earthquake has revealed that buildings constructed by materials like stone, bricks etc which were not particularly engineered to be earthquake resistant has cause many loss of life. It could have been minimized if the buildings were designed by the qualified architects and engineers. But most of the people in this region do not want to do so because they have a thinking that consulting and designing their buildings with the engineers is a waste of time and money. So they prefer to build their buildings with their own ideas or by just hiring the contractor. But any type of buildings in a seismically active region needs special attention because different buildings suffer different degrees of damage during earthquakes. Fig.1 shows the damage scenario of different non engineered houses due to

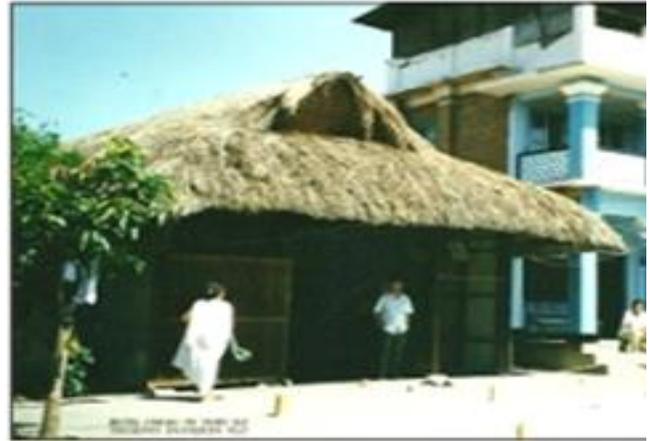
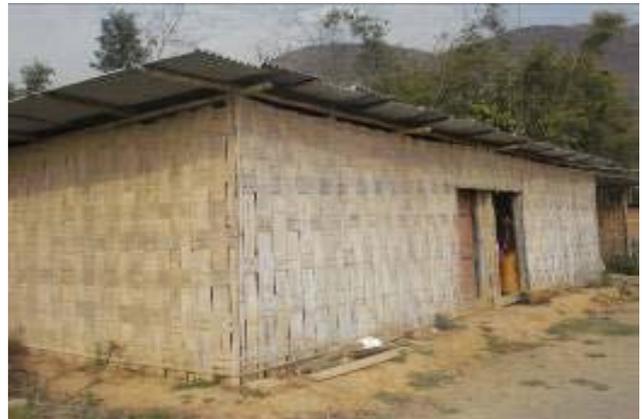
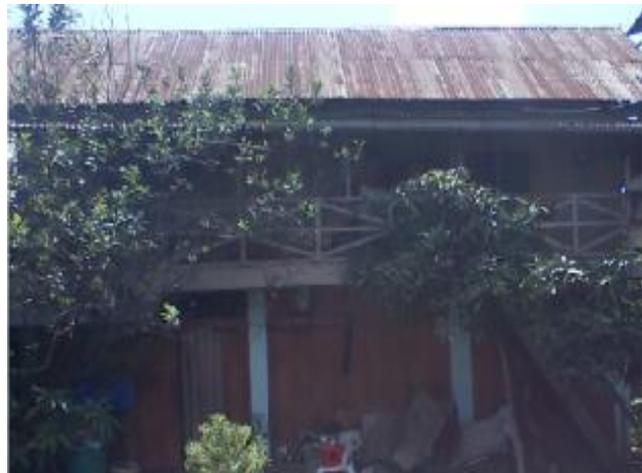
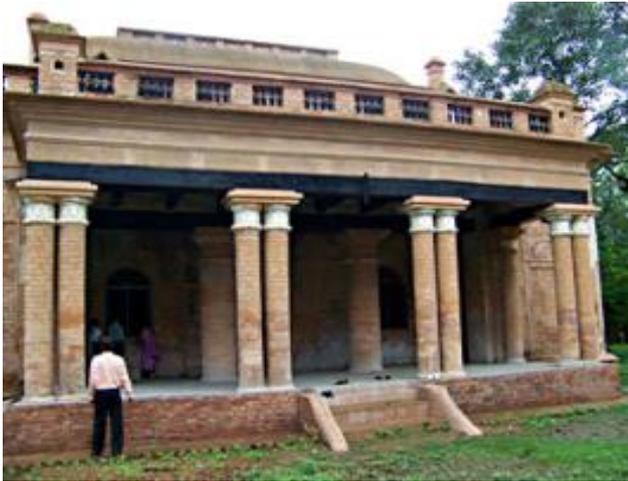
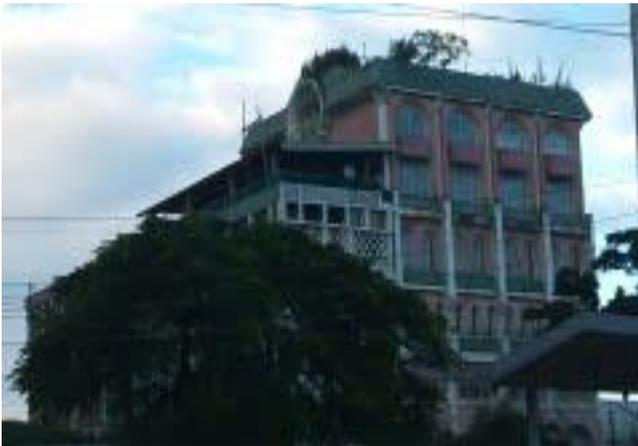
Fig. 2 Non Engineered construction

(a) Earthen house

(b) Bamboo house

(c) Timber house

(d) Masonry construction

(e) RC frame building

The earliest type of houses that were used to build was the earthen houses. One of the earthen houses that are practiced in Manipur is "Meitei Yumjao". It is built with bamboo of different size using locally developed technique as bamboos were easily and abundantly available. Now all the bamboo pillars have been replaced by wooden ones (Bahadur, 1994). And in Assam, the Ikra type of house is practiced where the walls are of timber frame work, inside those panels Ikra used to fill, and then it is plastered in both sides with mud mortar. Currently, these types of constructions are being built mostly in rural areas; in urban areas they are not used anymore.

Bamboo used in the construction of houses is either in the form of full culms or splits. In a bamboo housing system, the bamboo posts acts as compression members which are simply inserted into the ground and are tied with horizontal bamboo girders with the help of cane to give a proper shape. The Chin-Kuki groups commonly build houses in the pile-dwelling style. The Naga groups build houses having roofs made of bamboo splits and arranged in alternative turns (Bahadur, 1994). Bamboo mat are also made and nailed to either sides of timber frame to make a wall. Sometimes these walls are plastered with cowdung and mud. Nowadays, these types of houses with matt walls are more common in lower income family especially for temporary purpose.

Masonry buildings of brick and stone are superior with respect to durability, fire resistance, heat resistance and formative effects. Many temples and royal palaces were constructed with bricks. Apart from palaces and temples, there were also constructions of masonry building among common people. It became a common practice in those days. Those types of masonry building that were constructed by common people were only one to two storeys with box type. Some uses thick masonry wall. They stood well even today. Nowadays, lower income group who cannot afford to use rebars in their houses, build masonry building with one to two storey height.

RC frame building with infill bricks are common nowadays in urban areas. This type of construction started in Manipur around 1960 not so long ago. Multistorey of this type of construction started in 1970. Now almost all the buildings in Imphal are constructed with RC frame. The structural design of the buildings are not as per the IS codes. Normally 250 x 300 mm columns are used for constructing these multi-storeyed buildings, where as per the IS code the side of a column should be 300mm minimum. Building of extremely poor construction with all defect such as floating wall on gradually extended floor, poor mortar and brick work, feeble

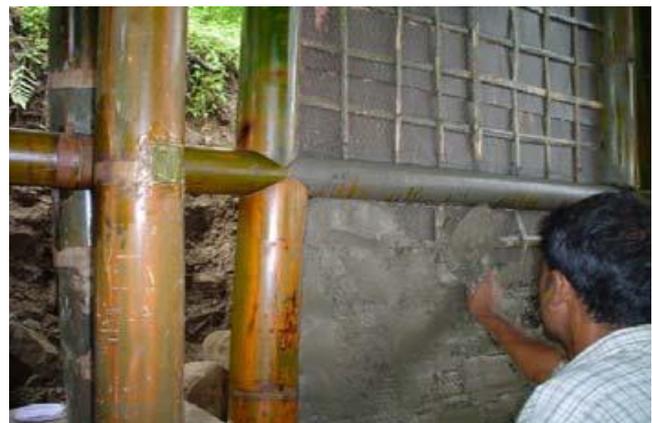
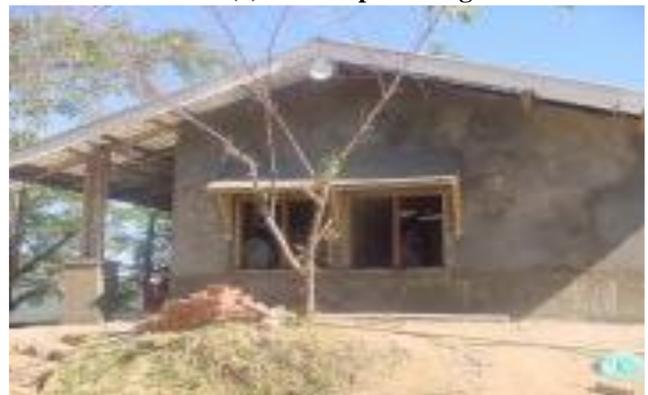
Fig. 3 Modification of earthen building

(a) Cement plastering

(b) A model of the modified earthen building in Mizoram

The ways the earthen houses are built are to some extent earthquake resistance because it uses bamboo, one of the earthquake resistant building materials. The roofing systems are also light in weight. Since it is lightweight, there is no danger of affecting the existing structure or disturbing the surroundings in any way. However, such houses require frequent repairs as earthen wall are damage due to heavy rain and thatched are required to be replaced due to decay and is vulnerable to fire. For the improvement of earthen house one can use cement plastered on bamboo mat walls. Proper foundation should be provided and the foundation is preferably being constructed using brick with cement mortar.

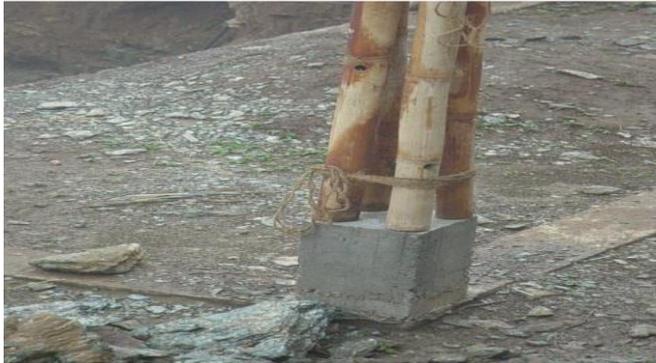
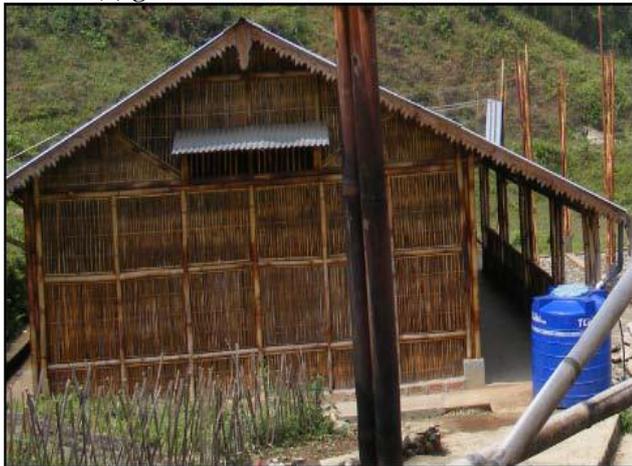
Fig. 4 A bamboo house

(a) grouted bar column base foundation

(b) a school in Darjeeling using grouted bar column base foundation

In bamboo houses, the bamboo itself is an earthquake resistant building material. However, there is no protection of bamboo/wooden posts against any natural cause like settlement or decaying or termites. And one of the most critical is the area of connection design. So before building such types of houses, one should consider all these into account. New techniques adopted by Mitch i.e. the grouted bar connection is a simple technique for column base foundation. This connection consists of a reinforcing bar embedded in a concrete foundation and then grouted into the bamboo column.

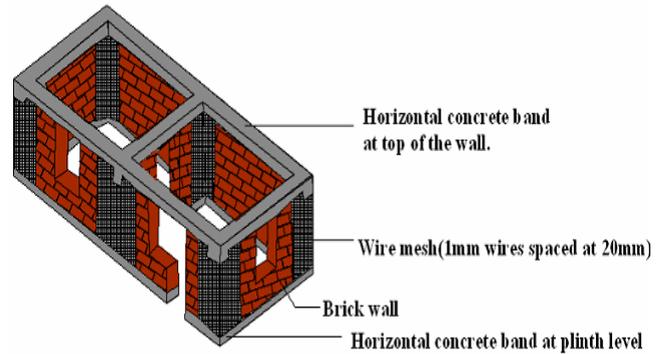
Fig. 5 Strengthening Techniques of Masonry House

The masonry, being weak in tension as well shear, when shaken horizontally during an earthquake, cracks very easily in various ways such as vertical bending cracks near vertical edges, horizontal bending cracks below roof and floor and above plinth. For this reason, it is reinforced, and one of the more popular reinforcing bars (rebar) is steel. But unfortunately not all part of the world is affordable. Scientists and engineers are constantly seeking for new materials for structural systems; the idea of using bamboo as possible reinforcement has gained popularity. Various experiments shows that, the modulus of rupture of bamboo is approximately one third of high strength steel and the bond strength of bamboo in mortar is well enough to use it as a reinforcing material in masonry, especially in Northeast India. Because the masonry houses built are generally one storied and the bamboo can easily be used as a reinforcing member for them. Use of bamboo will make the construction

cost within the limit of rural people. The strengthening technique of existing masonry house is shown in Figure 4.3.

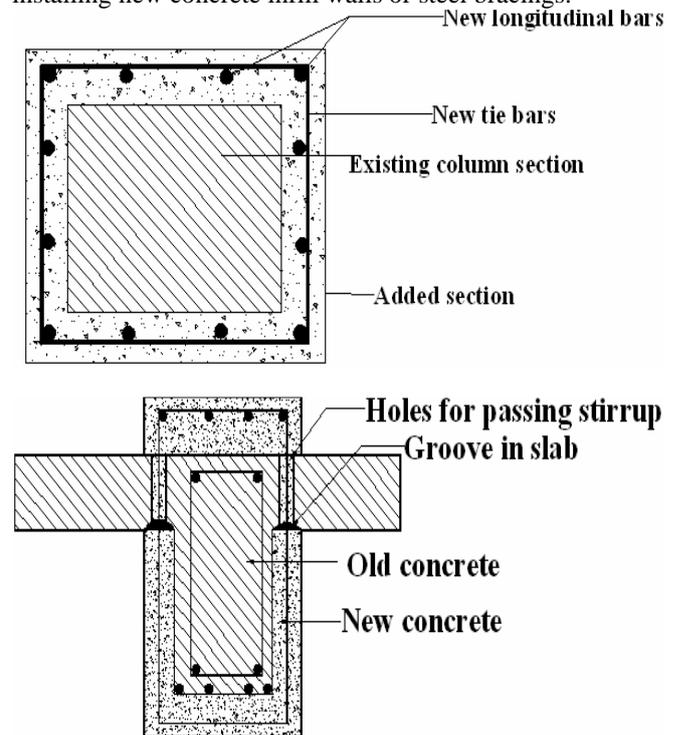
Fig. 6 Strengthening Techniques for Existing Non-Engineered RCC Buildings

Earthquake resistance in RC frame structures can be enhanced by either of the following approaches:

- Strengthening the components, such as columns and beams, by jacketing with concrete, steel, or fiber wrap overlays
- Increasing the overall capacity of the structural system by installing new concrete infill walls or steel bracings.
