Investigation of the Bond Strength Between Existing Concrete Substrate and UHPC as a Repair Material

Ahmed F. AlHallaq, Bassam A. Tayeh, Samir Shihada

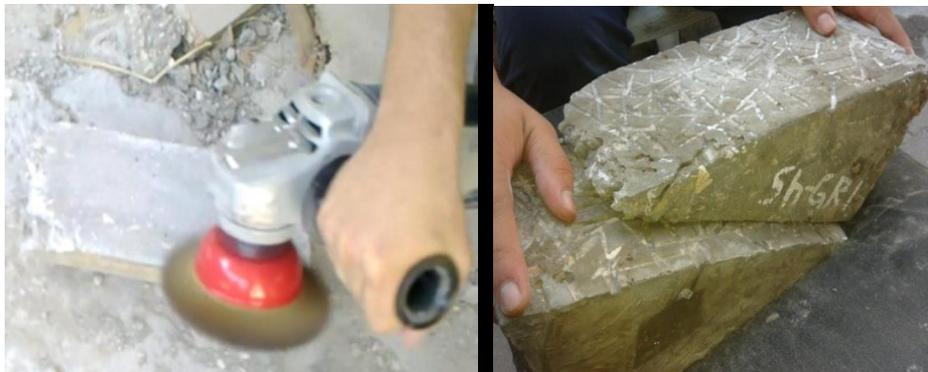
Figure 3: Wire brush and Random Scarifying Treatment Techniques.

- As-cast: is obtained by casting substrata surface against steel formwork,
- mechanical wire brush for 10 min/m²,
- scarifying was conducted by an electrical grinder to obtain a grid of parallel groves lines in two dimensions and random groves,
- scabbling by using a mechanical drill to obtain a surface partially chipped.
- Figure 3 shows the surfaces which were prepared using a wire brush and random scarifying.

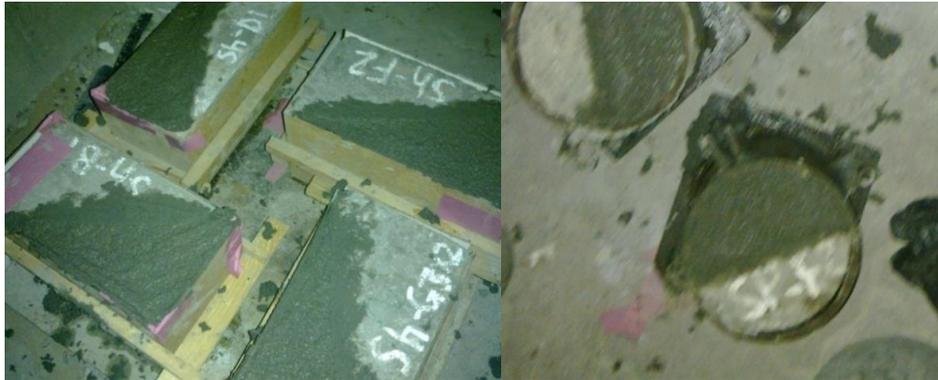
Figure 4: Slant shear and splitting test specimens.

The molds are prepared to contain substrata specimens and the cast repair materials casting. The remainder of the mold is filled with the repair material with good compaction, as shown in Figure 4.

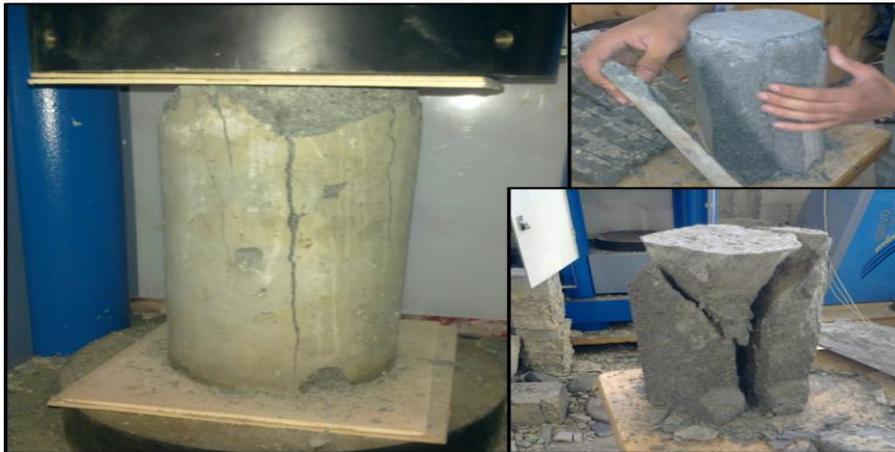
Figure 5: Mode of failure of UHPC cylinder.

The compression strength test was conducted, on the same day, of the bond strength test for substrata and repair material specimens. The standard cylinder specimens which are 30 cm in length and 15 cm in diameter are used to determine the compressive strength of the substrata and the repair material, Figure 5.

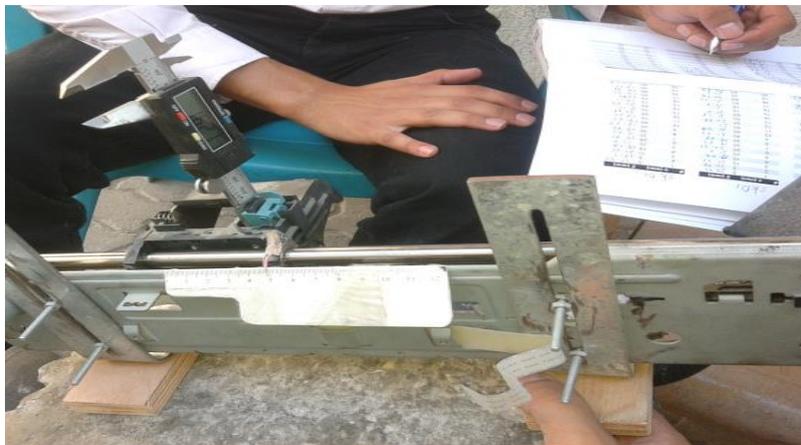
Figure 6: Surface Profile Mapping.

To evaluate the surface roughness, the specimens surfaces were mapped by the handmade profile meter. A two dimensional profile 10cm long was prepared 3 times in different locations on the surface for each specimen, shown in Figure 6. In this research, the surface roughness will be described using R_a coefficient, since this coefficient was used in most reviewed literature. This will allow comparing the results of this study with previous literatures.
