# Failure Analysis in High Pressure Feed Water Heaters and Method to Find the Defect in Tubes

**Abstract:** The aim of this study is to analyze the causes of tube failure of the high pressure feed water heaters in thermal power plants and to find out the defective tubes in high pressure feed water heaters using simple and economical method.

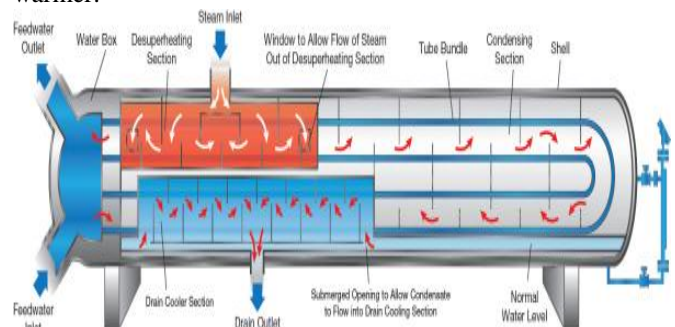
Figure 2 - Different zones of Heater

In shut feed water warmer, water courses through the cylinders in the radiator and drain steam consolidates outwardly of the cylinders in the shell. The shut feed water radiator has three zones[1],[3],[5].

The approaching steam enters this zone, surrendering the vast majority of its superheat to the feed water leaving from the warmer.

All feed waters have this zone. The majority of the steam is dense here, and any outstanding non condensable gases must be evacuated. An enormous level of the vitality included by the radiator happens here.

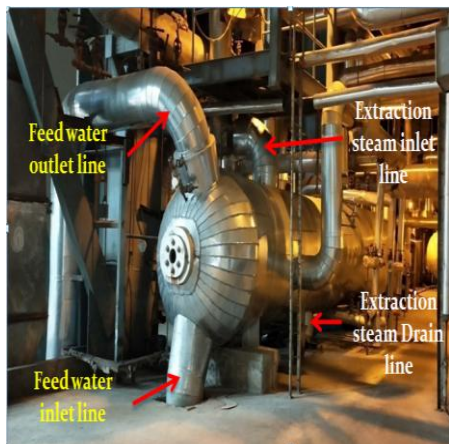
Figure 3 - High pressure feed water heater

In warm power plants, High Pressure ( H.P ) feed water radiators are associated in feed water line between Boiler feed siphon and economizer. There are two sorts of feed water radiators are utilized in warm power plant.

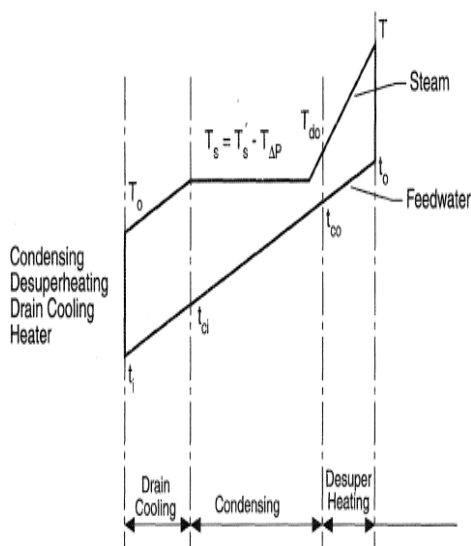
Figure 4 - Temperature graph

The temperature profiles for a high-weight feed water warmer which gets superheated steam separated from a high-weight turbine.

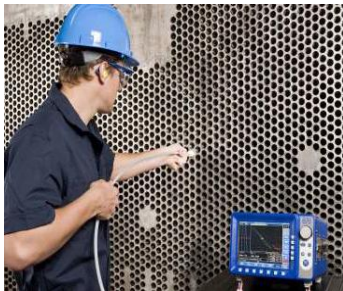
Figure – 5 Eddy Current Test

Eddy Current Test were carried out in defective high pressure feed water heater to find the defective tubes using probes. During this test, thicknesses of the tubes were measured and weaker tubes were identified. Most of the tubes affected in De – Superheating zone area was noticed during this Eddy Current Test

From the Eddy current test, thicknesses of the heater tubes are measured and percentages of eroded tube thickness were noticed. Also weaker tubes are identified and plugged.

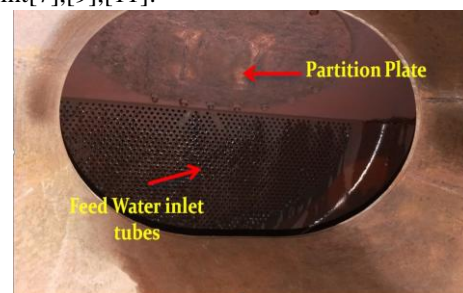
Figure 6 -View of water tubes in heater

To find out the probable causes of failure of the tube, it is essential that the exact location of each failure must be known. Before conducting air leak test in high pressure feed water heaters, tube and shell side water must be drained.

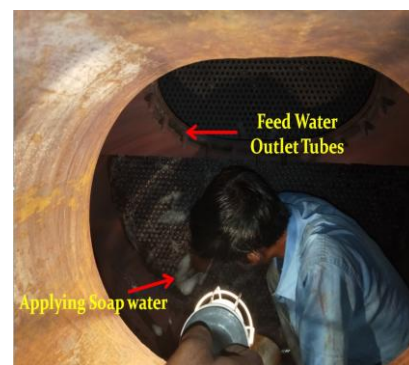
Figure – 7 Soap water test

In this technique air is utilized as working medium. At first 0.2 kg/cm<sup>2</sup> air is to be applied on the shell side. The substance of the cylinder sheet is secured with cleanser water to distinguish any air spilling out of the open parts of the bargains with a disappointment. Whenever discovered air spill, close the two parts of the bargains utilizing elastic plugs. On the off chance that no cylinder breaks are seen, gradually increment the pneumatic force to a limit of 7.0 kg/cm<sup>2</sup> . Utilizing the Probe to find the cylinder spill. Addition the test into the spilling tube. This will close wind stream the inclusion part of the bargain until the test has been embedded far enough to arrive at the purpose of disappointment.

When the test crosses the region of cylinder disappointment, air will victory of the plastic cylinder is to be submerged in water. An expanded progression of air pockets in the water demonstrates that a hole has been found. On the off chance that the disappointment is extremely little, air will quit blowing through the opposite part of the arrangement water

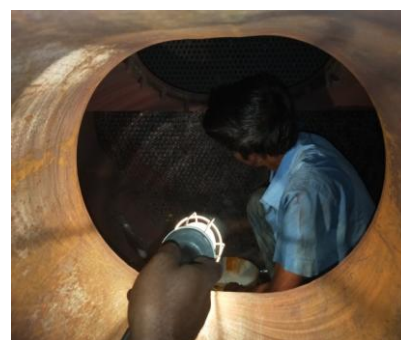
Figure 8 - Inspection of Water tubes

On the off chance that the disappointment is for some time part, air will keep on smothering of the two closures until the test has been progressed over the opposite part of the bargain. The test is to be moved to and fro gradually to recognize the two parts of the bargains. The length of the disappointment is equivalent to the separation moved short 50 mm. When a disappointment has been found the profundity of the break into the group is to be dictated by estimating the length of test embedded into the bombed cylinder. Where cylinders have bombed legitimately behind the cylinder sheet, especially consideration ought to be given to the cylinder to cylinder sheet joint[7],[9],[11].

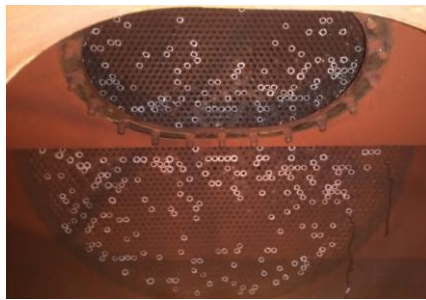
Figure – 9 Identified punctured tubes

From the air leak test, it was noticed outer diameter of the tube side defects in feed water heater and also exact location of the failure occurs in the tubes were measured. Also Tube to Tube sheets defects are identified.

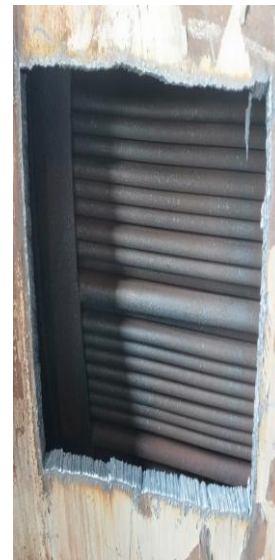
Figure – 12 Feed water Heater Tube Bundles

In some types of corrosion, visual examination can suggest the cause of failure and mechanism of attack. A photograph is usually recorded for subsequent reference and comparison of defects. Corrosion pitting of steel may be present in variety forms, it caused by dissolved oxygen in the working fluid. The pitting is commonly in the form of shallow oval pits overlaid with brown.

From the visual inspection of the defective feed water heater tubes, most of the defects are found in the tubes in de-superheating zone and these tubes are severely affected in outer side of the tubes due to erosion and pitting problem.
