Heavy Metal and Water Turbidity Impact on Corroded Patin Fish Cages in temerloh River, Pahang, Malaysia

Muhamad Hellmy Hussin, NurAzida CheLah

Index Terms: Corroded Y-bar, Water turbidity, Heavy metal, Weight loss, Fish Cage

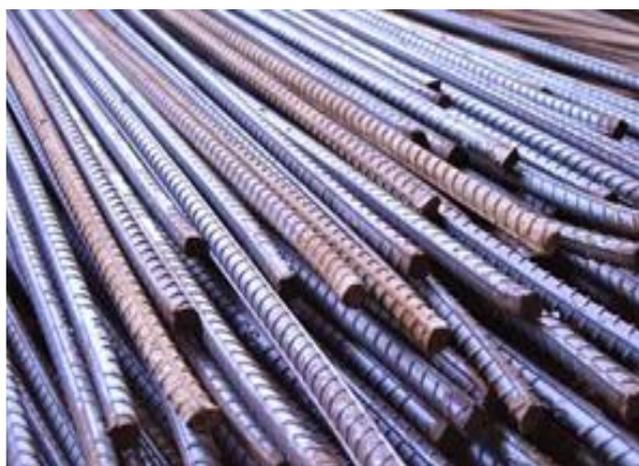
Fig. 1 Y-bar reinforced steel

Fig.1 shows the Y-bar reinforced steel used in this study. The 6 ft Y-bar samples were cut according to the size of 30 mm in length and with diameter of 10 mm. The samples surface were grounded using grinding machine to remove the unnecessary part until the ridges surface became smooth and it was done at the early stage before test measurement.

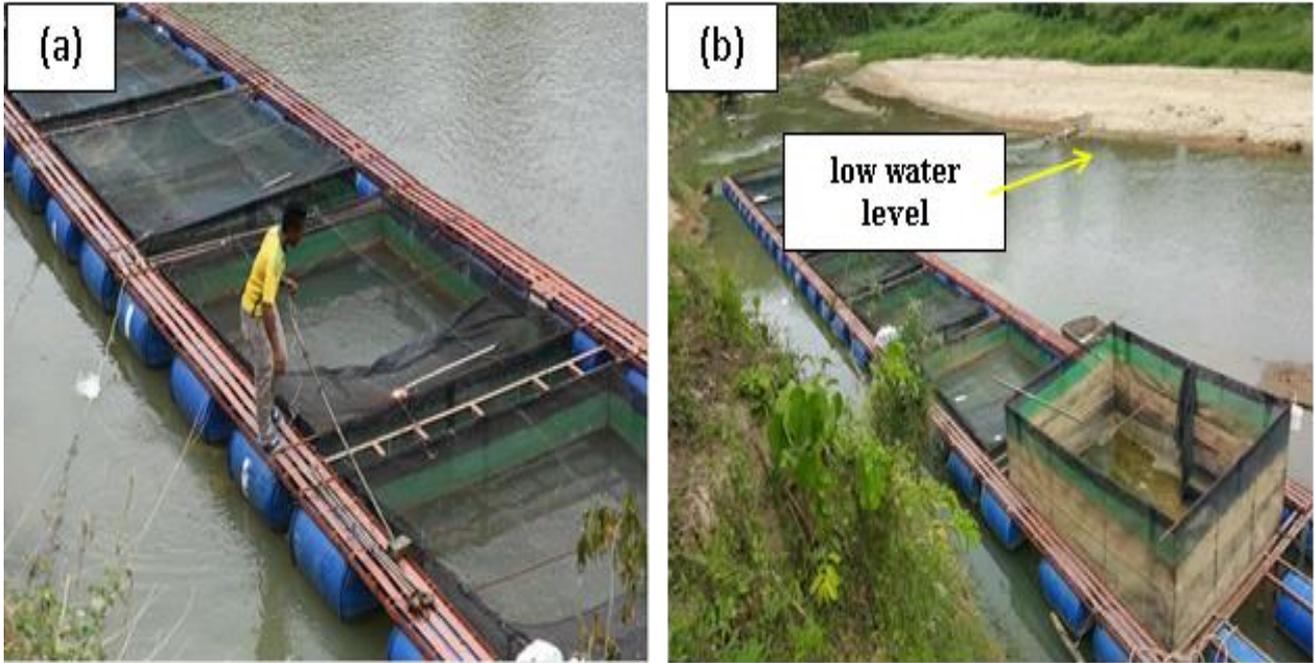
Figs. 3 and 4 show the location of submerge test and the Patin fish cages at Temerloh, Pahang, Malaysia. The polished and pre-weighed coated and uncoated Y-bar steel samples were tightened and placed adjacent to the real Patin fish cages. All the coated and uncoated samples were submerged at 1, 2, 3 and 4 ft. depth. At the end of submerging test, the samples assessed by weight-loss measurement. The coated and

Fig. 3 (a) Patin fish cages in Temerloh, Pahang River, and (b) low water level at Pahang River specific location where the test location took place.

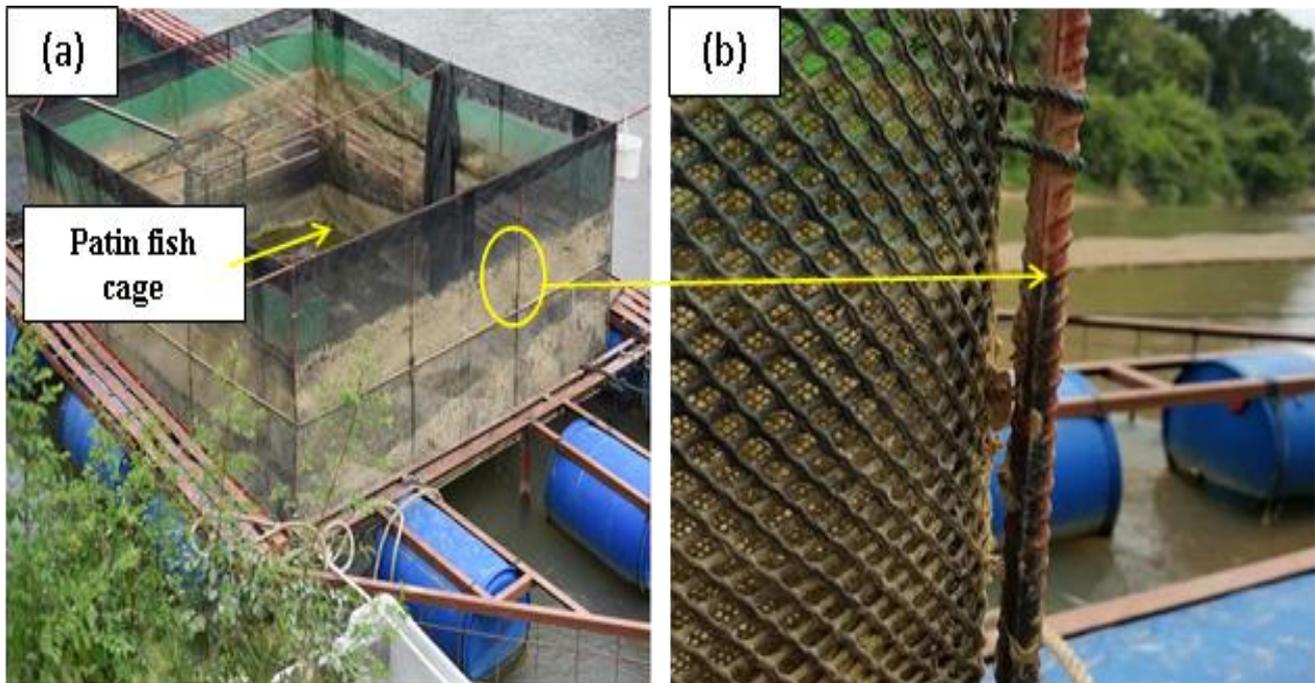
Fig. 4 (a) Patin fish cage made of y-bar steel in Temerloh, Pahang River, and (b) enlargement of y-bar steel structure of Patin fish cage.

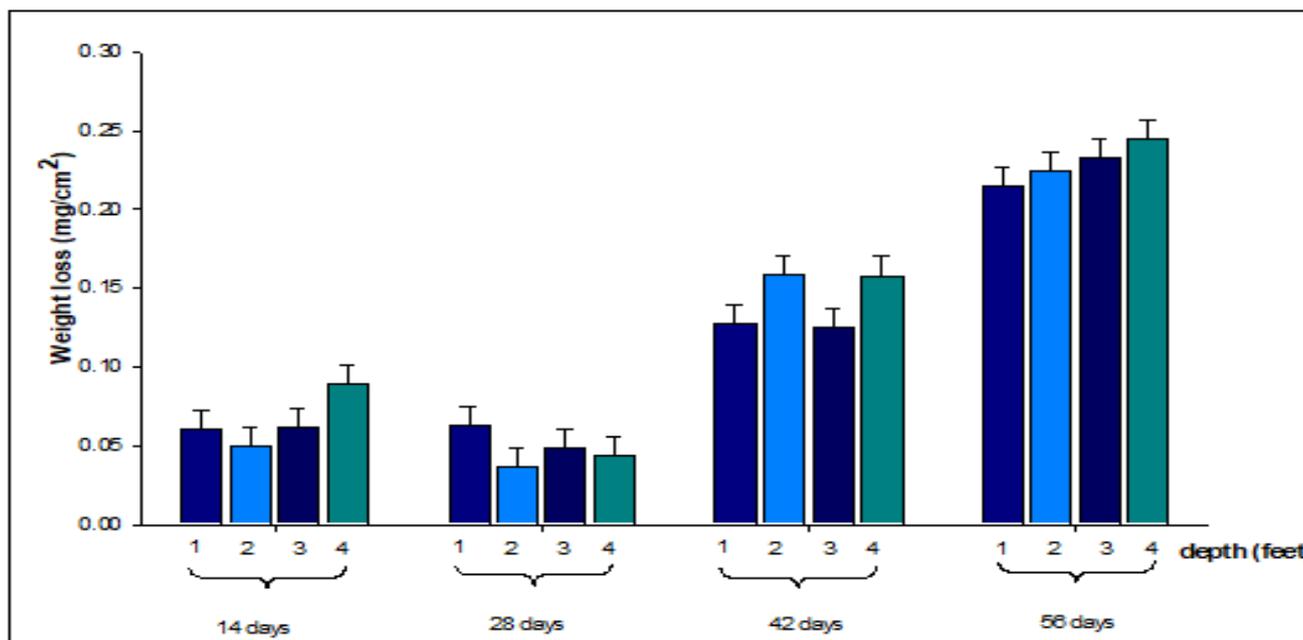
In this work, the analyses were focused on uncoated Y-bar steel samples that were submerged in river water adjacent to the location where the fish cages were located for 14, 28, 42 and 56 days. These uncoated samples show an increment of weight loss as shown in Fig. 5. It shows that, the weight loss was drastically increased after 42 and 56 days of submerging samples in river water. It also shows that after 56 days of the test, uncoated samples show higher weight loss recorded which the difference is about 80%. This statement is in agreement with all the factors influenced such as heavy metal content, and water turbidity as indicated in Figs. 6 until 7.

Fig. 5 Weight loss of corroded uncoated y-bar steel submerged in Temerloh, Pahang river water.

The result of the weight loss analyses in Fig. 5 shows the effect of submerging samples of Y-bar steel in the river water. In this case, the effect of heavy metal and water turbidity of the river water itself were extensively studied to determine the factors involved in accelerating the corrosion process of Y-bar steel cage structures. The result of heavy metals in river water adjacent to the place where the sample was located is presented in Fig. 6. As well known, heavy metals are also called "trace elements" and they are basically metallic elements which can be found in the periodic table. It

The findings of this study showed that, the uncoated samples show an increment of weight loss and it was drastically increased after 42 and 56 days of submerging samples in river water. It also shows that after 56 days of the test, uncoated samples show higher weight loss recorded and deeper the depth, the higher the weight loss recorded.

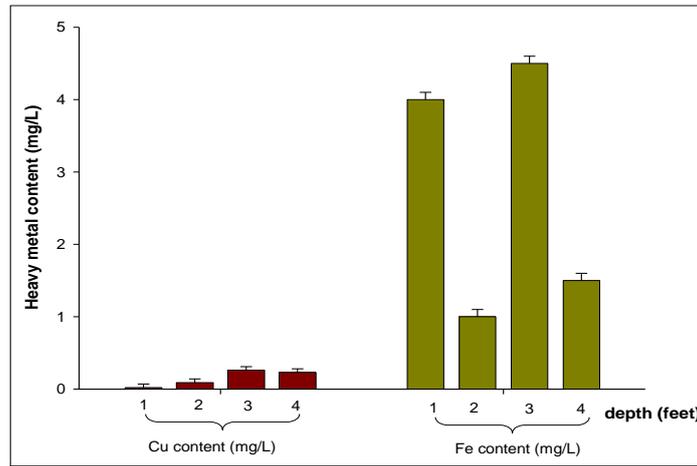
becomes an important interest in recent decades when it deals with the specific surrounding environmental investigation. In Fig. 6, it shows that the concentration of Cu ranged from 0.02 to 0.26 mg/l in the river water sample. The lower limit of Cu in the river water sample was determined at 1ft. depth location and the upper limit at 4 ft. depth. Meanwhile, the concentrations of Fe in river water sample was higher compared to the concentration of Cu. Similar pattern was found for Fe concentration and it shows that the lower limit of Fe was determined at 1ft. depth and the upper limit was recorded at 4 ft. depth.

According to the Fig. 6, there were variations in the concentrations of heavy metal depends on the depth of river water where the samples were submerged. This could be attributed to the lower volume of water due to the lack of water flow from the Tembeling and Jelai rivers upstream that flow into Sungai Pahang in July till December 2015. Thus, this will influenced the high concentrations of some metals measured at the low water level area adjacent to the place where the samples were submerged.

Fig. 6 Heavy metal reading of river water adjacent to the Patin fish cages at 1 to 4 ft depth.

As well known, Cu is one of the metal element that are biochemically transformed by microorganism to organic metal compounds prior to becoming toxic. Corrosion and scaling are related phenomena and thus, chemical are vital to minimize. In this case, the concentration of Cu is lower compared to the concentration of Fe. Although Cu is toxic, since the level of Cu is 70% lower compared to the Fe, it will not fully harm the fish. In the meantime, the presence of heavy metals will degrade the water quality and affects the fish or other aquatic animals. It is mainly important for human being. This also implies that the river water is contaminated and polluted with Cu and Fe, could be attributed to dumping of decaying metal components and also because of submerging the structure of steel cages.

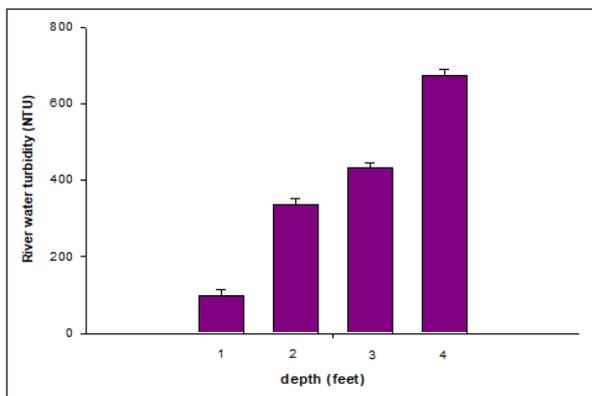
Instead of lack of water flow, the shallow river water level was found due to much water sedimentation caused by deforestation. In this issue, deforestation causes soil erosion due to rain falls and turned the soil to loose. Due to this problem, the river turned brown and become worsen as the soil rushes and falls into the river water. This is in agreement with water turbidity level as shown in Fig. 7. It shows that, the peak of turbidity levels in the river water sampling tended to be higher which is 673 nephelometric turbidity unit (NTU) at 4 ft. depth than those in 1, 2 and 3 ft. depth. At shallow depth, the water turbidity level is low since it is free from precipitation.

Fig. 7 Water turbidity reading of river water adjacent to the Patin fish cages at 1 to 4 ft. depth.

Besides deforestation issue, this problem could be attributed because of the fish movement and the river water velocity. This turbidity brings along all the impurities such as plant, muddy and it was found precipitated below the depth. The source of river water pollution in Patin fish cages usually leads to the higher turbidity level including poor water clarity, algal blooms and lack of submerged plants.
