Repeated Weld Repair and its Influence on Welded Carbon Steel

NurAzida CheLah, Muhamad Hellmy Hussin

Abstract: *Weld repair usually comprises of mechanical removal of weld part and redistribution of the filler wire using the same parameters. The defect may be removed by carbon arc gouging and grinding or machining. The strength and the microstructure of the material will be changed when the repeated weld repair is applied to the material at the same area. The purpose of this study is to compare and identify the angle of distortion, hardness, and tensile strength and bend strength and to analyze the macro and microstructure between repairing method using carbon arc gouging and mechanical grinding process with the same number of repairing sequence. The result proved that repairing A36 steel increased the strength of the material itself but the ductility was decreased when the number of repair increases. It can be concluded that, the repair using carbon arc gouging can't be applied to repair weld joint for material because it's more significant to change the material process compared to mechanical grinding. Overall, the mechanical grinding technique is the most suitable practice whi

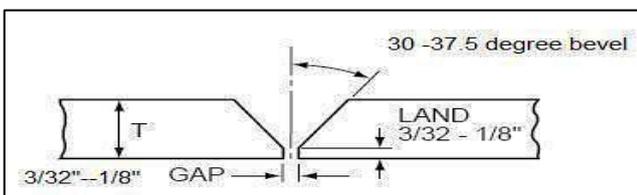
The joint design use in this experiment is single-V joint according to the suitable selection depends on the 9 mm thickness. Groove angle of 60 degrees, root face thickness of 3mm and a root opening of 1mm gap.

Fig. 1 Side view of single groove butt weld

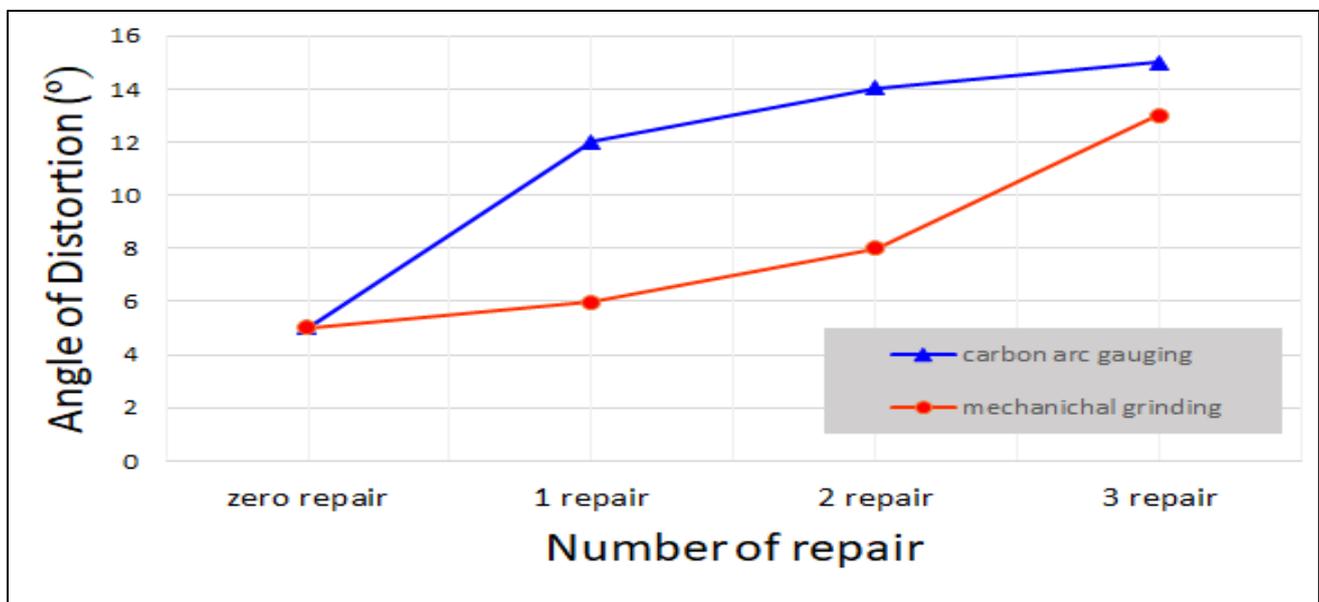
The angle of distortion was measured using 180-degree protector angle and the data was recorded manually. This observation is to determine the change of angle distortion when repeated weld repair were carried out. Fig. 2 shows the angle of distortion increases when the number of repeated weld repair increases. The increasing of angle distortion from show specimen repair using carbon arc gouging is more significant compared to the specimen repair using mechanical grinding. The angle of distortion for the specimen without been repair is 5°. Then, the angle increases for the specimen once repair using carbon arc gouging is 12° and for the specimen repaired using mechanical grinding is 6°.

The angle of distortion continues to increase, for the two times repair process. It shows that the specimen that used carbon arc gauging process, the angle of distortion is 14° increased to 15° and for specimen repaired using mechanical

grinding shows an increment from 8° to 13°. The change of angle distortion for the specimen repair using mechanical grinding are not much increase for each number of repair process compare to repair process using carbon arc gauging.

Fig. 2 Angel of distortion for both methods of repair processes.

The change of angle distortion is noticeable for the specimen repaired using carbon arc gauging and it shows that the repair process using carbon arc gauging is more significant for distortion to occur compared to repair using mechanical grinding. This is due to the high heat input involved during repair using carbon arc gauging compared to

mechanical grinding. In this case, repeated heat input influenced the increase of angle distortion because in single-V welded joint, the first weld run produces longitudinal and transverse shrinkage and rotation.

Meanwhile, the second run caused the plates to rotate using the first weld deposit as a fulcrum, and non-uniform contraction will produced angular distortion. Therefore, for the welded joint that involved multi-repair welding process at the same area, must be carefully focused especially in controlling the cooling time in order to reduce the distortion. However, in this case the same cooling time applied but the difference is the heat input of the method use, and the number of sequence the repair involved. It shows an increment of distortion angle for both method.

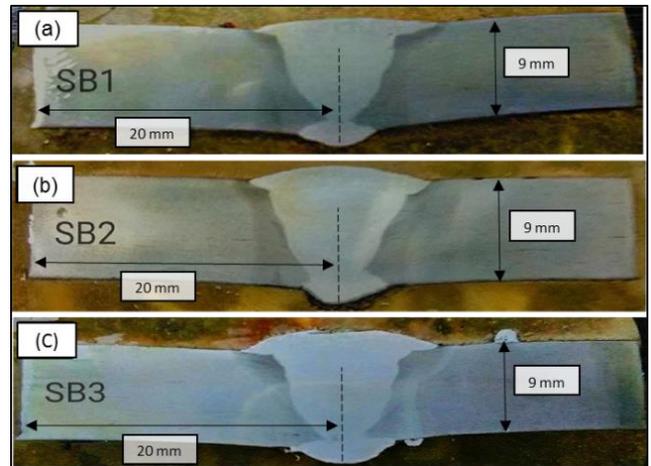
Fig.5 Macro etch cross-section of samples repair using mechanical grinding (a) once repair, (b) two time repair, and (c) three time repair

Macrostructure result provided in Fig. 3, 4 and 5 shows significant difference of observation. It shows that the weld shape was consistent for all samples, and this was to be expected since the joint geometry was machined in the same fashion prior to welding with the same parameters. Weld area size was different between all samples, because the difference of theremoval part method that affect the joint geometry. The weld area size increaseswith the number of repair process. This could affect theweld removal part and also reduction of the weldment. The main difference significantly shows by the size of HAZ and it is indicated that the repair method using carbon arc gauging increased the HAZ size compared with repair method using mechanical grinding in Fig. 3 and 4. The size of HAZ was significant especially for sample using carbon arc gauging compared to mechanical grinding, as shown in Figs. 4 and 5. Moreover, the repair process using carbon arc gauging shows more significant difference especially on the geometry changes because of the arc used during the repair process. This could leads to non-uniform geometry shapecompared to the mechanical grinding's repair process.

As shown in Figs. 4 to 8, it shows there are no significant changes at BM region because this region was not affected by the heat generated during welding process. This is suggested to be the reason why the BM shows similar observation of its similar microstructure.

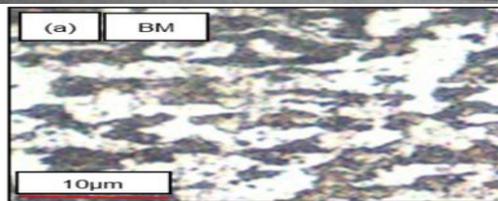
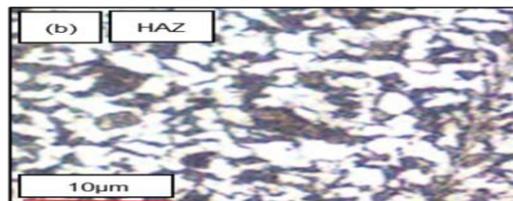
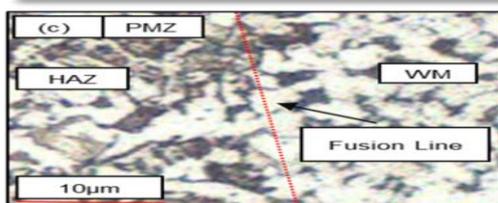
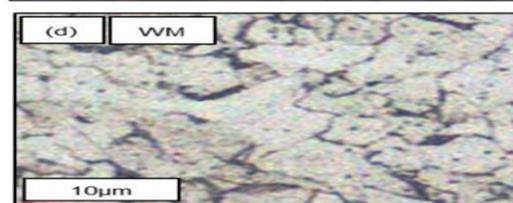
Fig. 6 Microstructure images of welded sample with and without repairing work (a) base metal,(c) heat affected zone,(d)partial melted zone and (e) weld metal

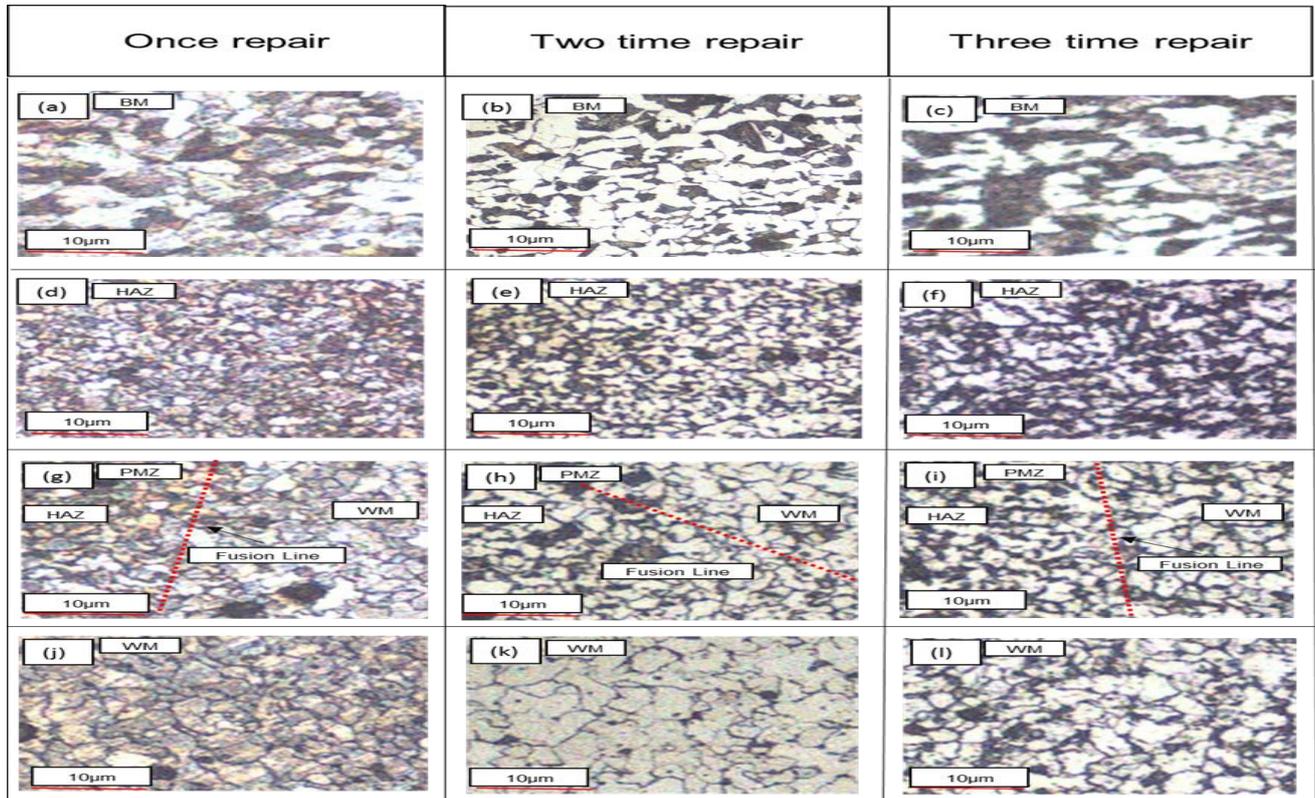
Fig. 7 Microstructure images of welding repair sequence using carbon arc gauging in (a) base metal, (d) HAZ, (g) PMZ (j) weld metal.

As shown in Figs. 7 and 8, it is indicated a similar pattern of fusion boundary and no significant microstructural changes was observed for all specimens even the number of repeated repair increases. It is observed that the larger grain size was observed in BM region compared to HAZ region for all specimens for both mechanical grinding and carbon arc gauging welded joint. It can be suggested that this could be the reason of repeated weld sequence applied for all specimens.

As expected, the HAZ region was affected by the repeated heat during welding and repair process. From microstructure result at HAZ region, the grain size of HAZ on repaired specimen using carbon arc gauging shows coarser grain size compared to the specimen using mechanical grinding. This could be attributed by the heat generated during repair using carbon arc gauging compared to the method using mechanical grinding. Since the carbon arc gauging is a method that used an arc for weld removal part, it can be said that this could lead to the microstructural difference in HAZ compared to the repair method using mechanical grinding. The microstructure of HAZ region shows significant changes when the number of repeated repair increases, and this could be attributed by the heat applied especially at the same area.

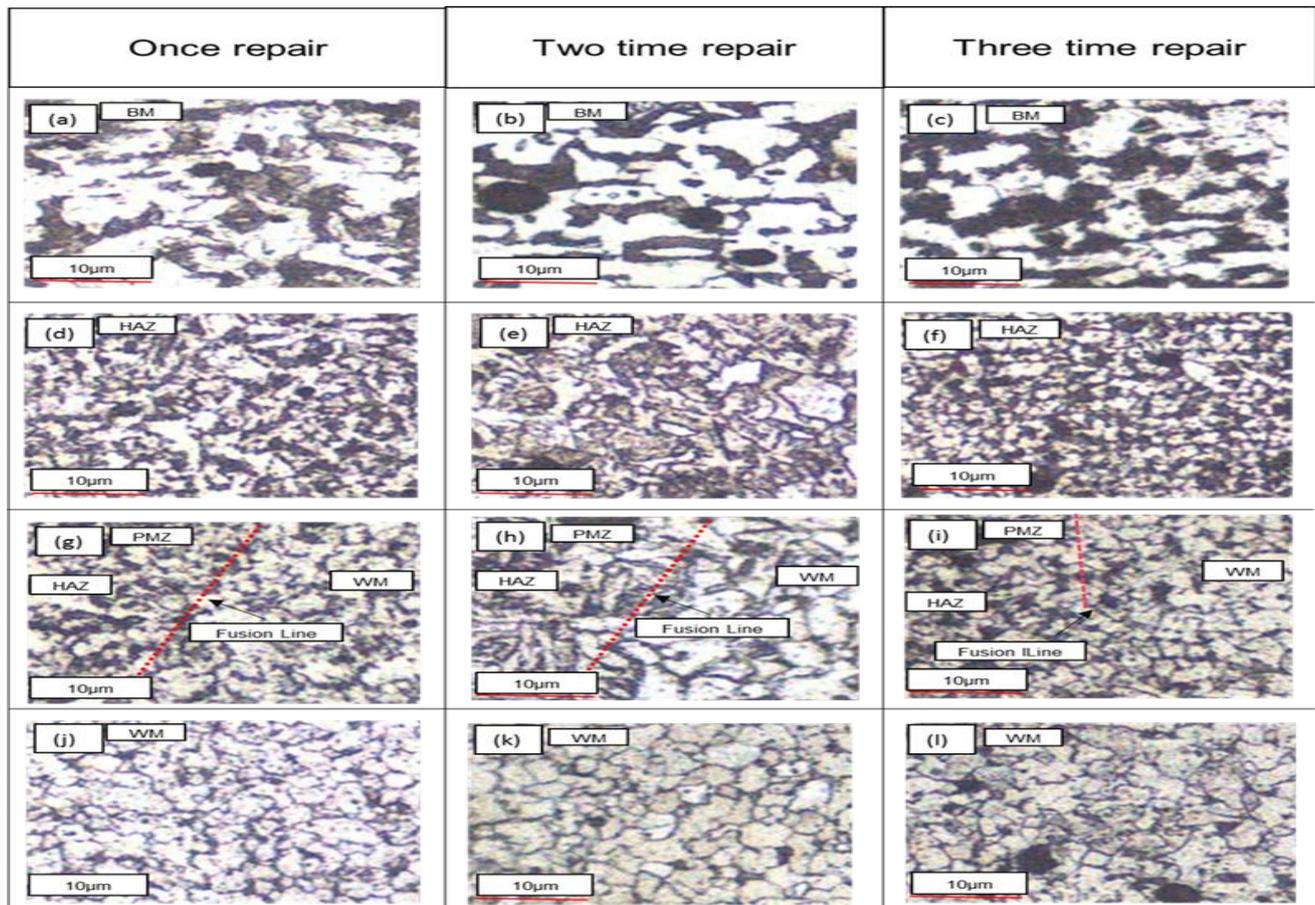
Fig. 8 Microstructure images of welding repair sequence using mechanical grinding in (a) base metal, (d) HAZ, (g) PMZ (j) weld metal.

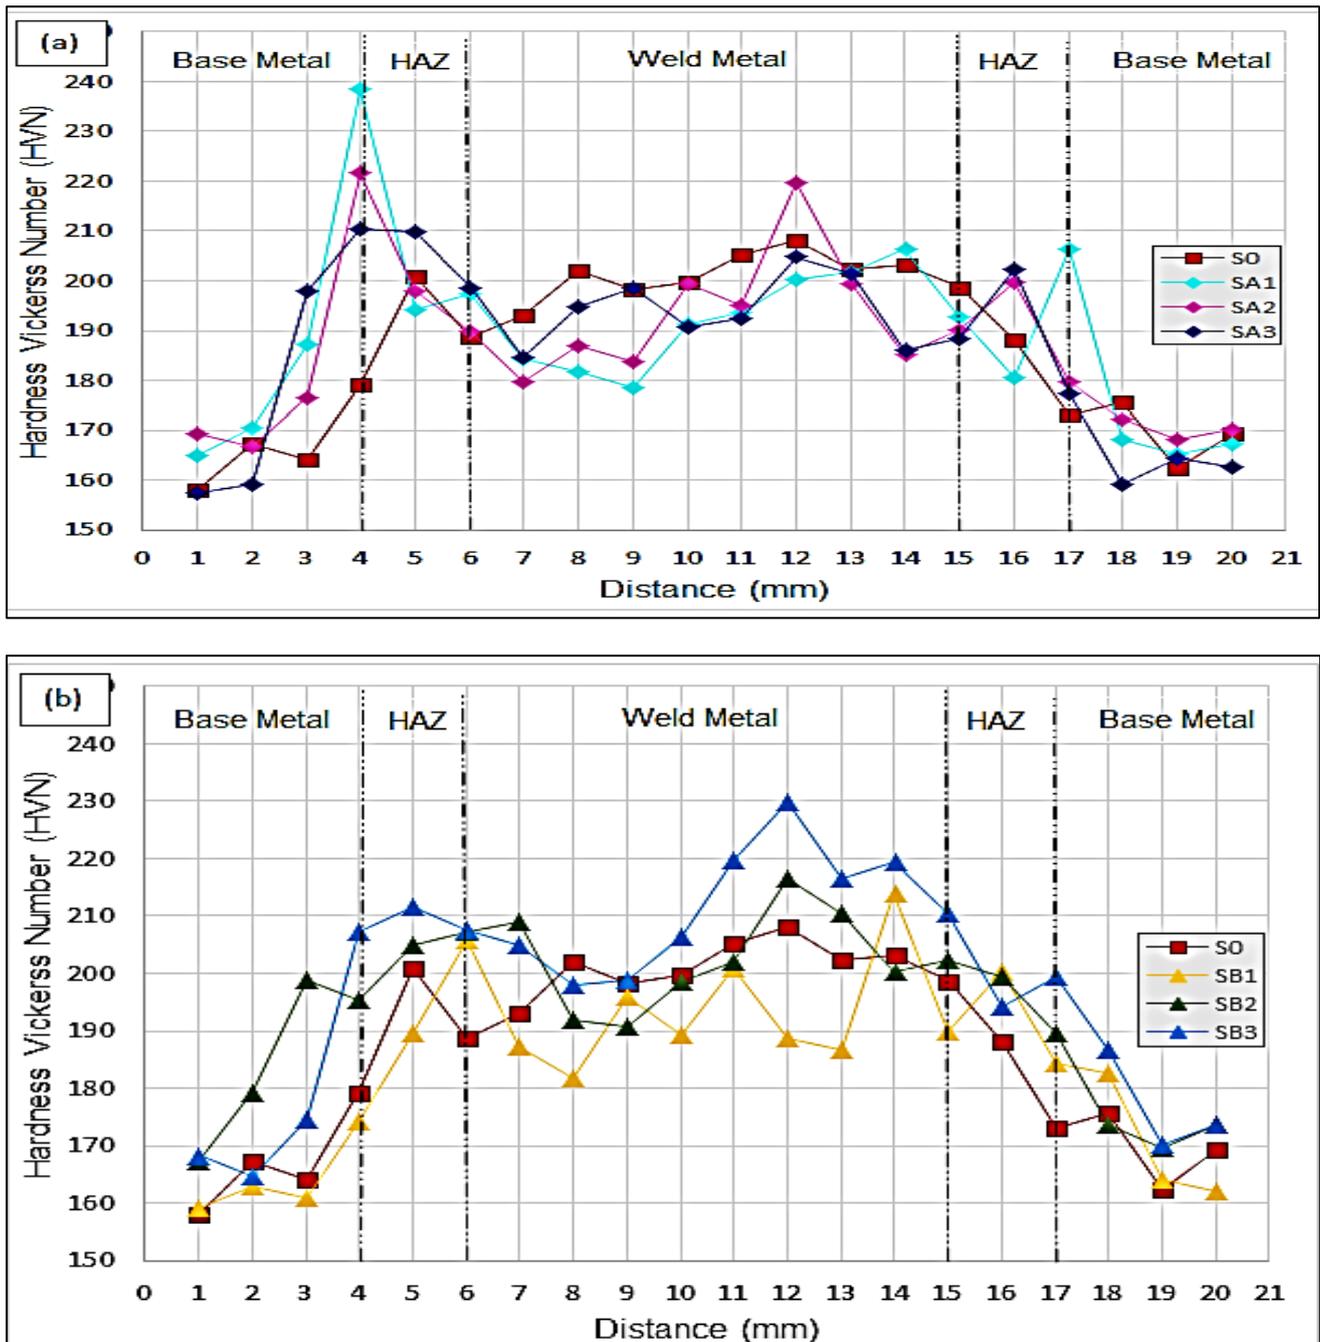
Fig. 9 Hardness profile of repeated weld repair using (a) carbon arc gauging and (b) mechanical grinding.

Hardness profile of the welds was illustrated in Fig. 9. The average hardness results of three regions which comprises of BM, HAZ and WM of all samples indicate that the hardness were relatively high at the HAZ for all sample. From the hardness profile result that shown in figure, the value of hardness at the area of HAZ will increase when the number of repeated repair using both methods of repair increased. This is suggested because of the area of HAZ that was affected by the heat during welding and repair processes. Hardness value was low at BM region show compared to HAZ and WM region for all specimens and this because the area was not affected by the heat during repair and welding processes.

It shows that the hardness profile for repaired sample using carbon arc gauging show an increase in the hardness value at the area of HAZ when the number of repeated weld repair increased as shown in Fig. 9. For the weldment area the hardness value number decreases as the number of repeated weld repair increases and this is suggested due to the repeated weld sequence applied and replaced with the new weldment during the repair process.

For sample repair using mechanical grinding the change or the increasing of the hardness value at BM, HAZ and WM region are not significant compared to the repair using carbon arc gauging. The hardness value at HAZ region for sample repair using mechanical grinding shows an increase at sample once and two time repair only and decrease at three times

repair sample. For the hardness value at WM region it shows that no significant difference was found for repaired sample using mechanical grinding compared to the repaired sample using carbon arc gauging that show the decrease on the weldment area.

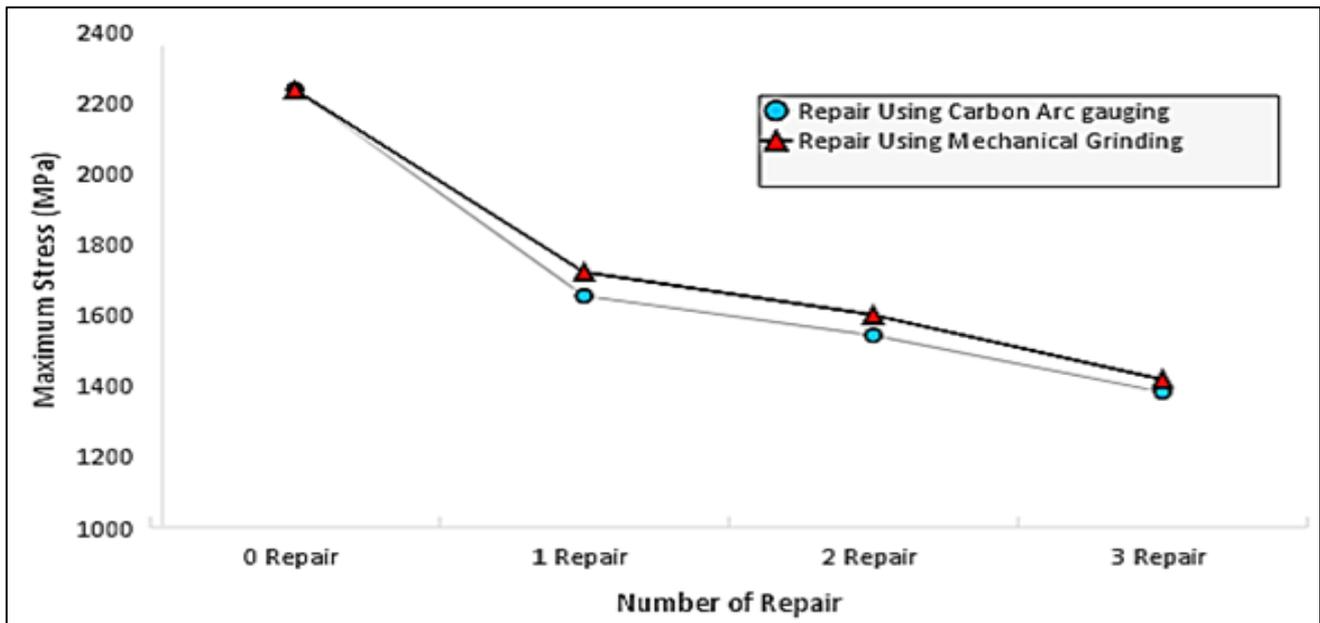
Bend test has been conducted as a method for measuring stiffness and yield properties of materials A36 after the material was repaired using carbon arc gauging and mechanical grinding. Bend test for ductility provide a simple way to evaluate the quality of materials by their ability to resist cracking or other surface irregularities during one continuous bend. In certain cases the bend test can determine its tensile strength. Having two method of repair welding has led to a finding that in terms of ultimate maximum stress as it confirmed by bend test. From the findings, the value of maximum stress before the fracture occurred for both methods of repair was decrease when the number of repair increases. As shown in Fig. 10, it is indicated that all the sample that involved with repair work was fractured that is occurred at weldment boundaries area which is HAZ. According to the ASME IX standard for the bend test requirement, it is stated that if the sample indicate fracture zone at any area of weldment, thus the sample would be rejected.

Fig. 10 Maximum stress before fracture of the repeated weld repair

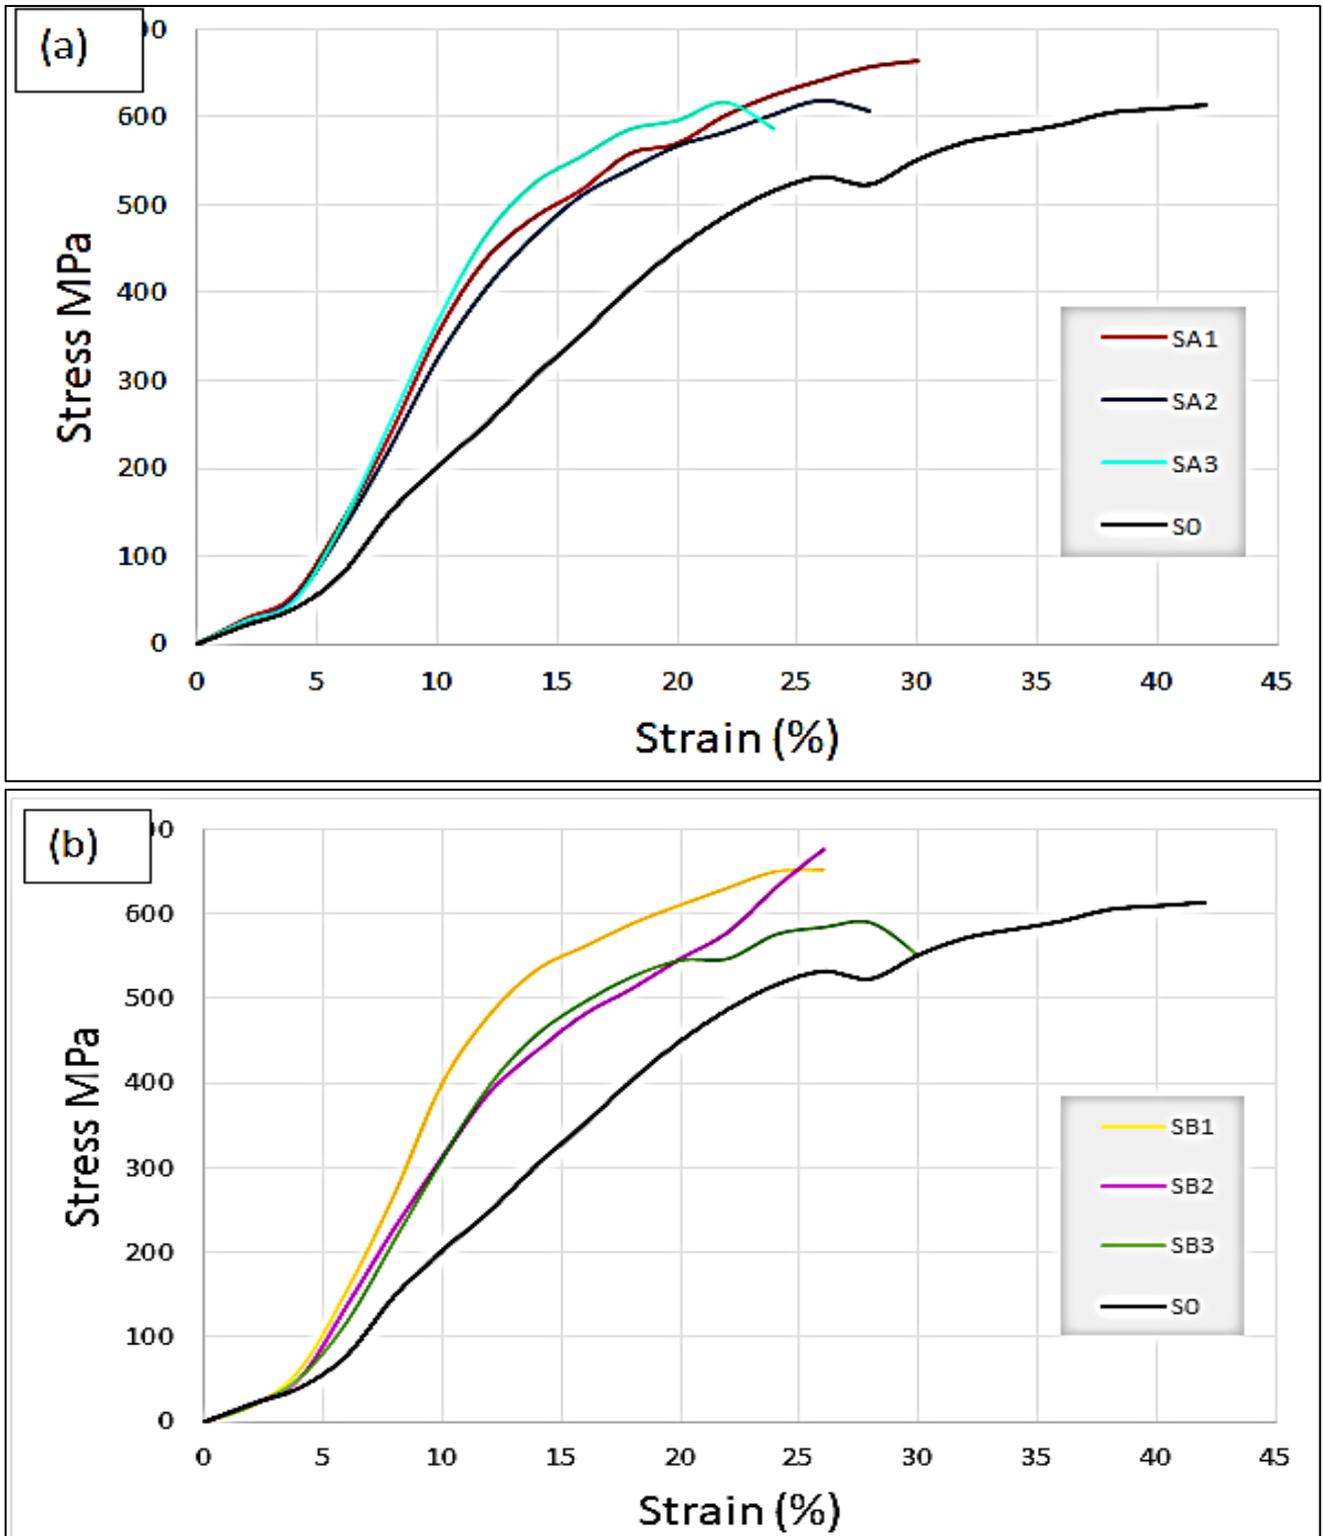
Tensile test proved useful in further understanding the effects of repeated welding operations on the mechanical properties of ASTM A36. From the stress-strain curve, as shown in Fig. 11, the sample without repaired (S0) shows an ultimate tensile stress of 613 MPa and the total strain is 16%. It also indicates that the sample has low ultimate tensile strength but high strain (ductility). Moreover, the ultimate tensile strength was found increases as the value of the yield strength increases. In this case, the sample that involved with

repair work shows to have high ultimate tensile strength compared to the unrepaired sample but the ductility of the sample was decrease.

Fig.11 Stress-strain curves representing tensile behavior for the repeated weld repair using (a) carbon arc gauging and (b) mechanical grinding

For the repaired sample using carbon arc gauging, it was observed that the sample fractured at the HAZ and for the repaired sample using mechanical grinding, only two samples fractured at the HAZ and other one break at BM.

For sample repaired using mechanical grinding that involved with one time repair, the sample was found fractured at BM. Ductility of the sample was found decreases as the number of repeated of weld increases. It was proved by the decreasing of the elongation of the sample before fracture. It is also in agreement with the high hardness

value at the area of HAZ. It is also indicated that the sample that involved with repair work for both methods shows to have high ultimate tensile strength with low ductility compared to the unrepaired sample that has low ultimate tensile strength but high ductility.
