Retrofitting of a Damaged School Building: A Case Study

Abstract— A three story damaged school building which has developed multiple cracks in floor slabs is investigated and analyzed. The building vertical load paths are determined and failure patterns studied. The retrofitting (strengthening) measures are worked out. The building is provided with suitable strengthening features to limit the damage and prevent future damages.

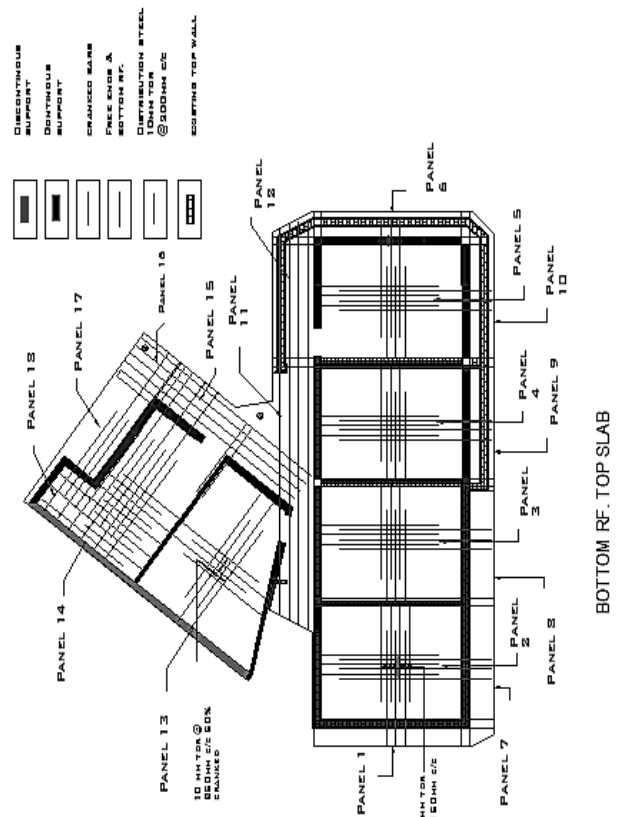
Fig. 7 Bottom Reinforcement Provided in Top Floor Slab

B. The slab analysis is performed by breaking the slabs into individual panels and implementing yield lines [4]. For each panel, the loaded moments are calculated (Fig. 5 and Fig. 6) and reinforcement required is determined. The reinforcement provided is checked by bar detector (Fig. 7). Thereby flexural check is performed. Besides, the shear check and deflection check is performed to gain additional information. For top slab given in Fig. 5, the panel 6 is failing in flexure while as for first slab given in Fig. 6, panel H, I, J are failing in flexure and shear after check. It is seen that overall bearing strength of soil is less than $50T/m^2$ and is safe in bearing strength.
