Discontinuity Mapping using Terrestrial Laser Scanner and Kinematic Method

Rasyikin Roslan, Rohayu Che Omar, Intan Nor Zuliana Baharuddin, Warishah Abdul Wahab,
Faten Syaira Buslima

The purpose of this study is to provide the current site and slope condition of comprehensive geological study using terrestrial laser scanning and discontinuity survey at Simpang Pulai, Perak.

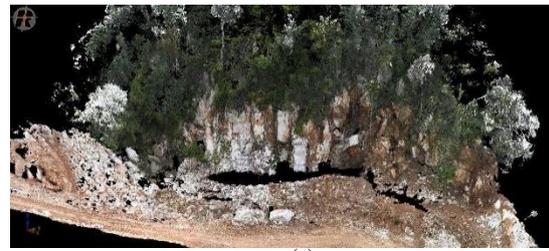
Fig. 3 Terrestrial Laser Scanning (TLS) survey for (a) Area 1, (b) Area 2, (c) Area 3, (d) Area 4, (e) Area 5, (f) Area 6

Fig. 7 shows the kinematic analysis for Area 2. This analysis came from 120 readings of the discontinuity survey along this area. There are two potential failures identified in this area which are plane and wedge failures.
