# Failure Characteristics on ADNAN (Malaysian Armoured-Vehicle) Track Shoe and its Improvements

Muhamad Hellmy Hussin, NurAzida CheLah, Shamsul AkmarAbd. Aziz

### C. ADNAN Malaysian Armoured Vehicle Track Shoe

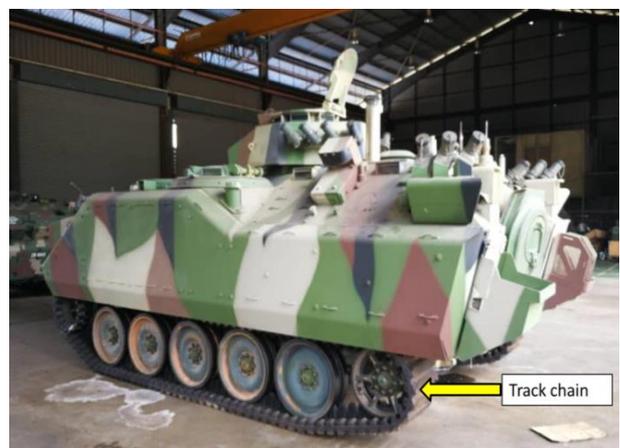
Fig. 2. Track chain ADNAN- Malaysian Armoured Vehicle

A real photo showing the track chain of ADNAN, an armoured vehicle of Malaysian Army as depicted in Fig. 2. The Malaysian variant of the AIFV (Armoured Infantry Fighting Vehicle) is called ADNAN. The name of ADNAN is given after Adnan bin Saidi, who was a Malayan Lieutenant and a hero who fought in the battle of Singapore during World War II. The ADNAN track link blocks with rubber pads are connected by means of track pins and the end connectors as shown in Figs. 3 and 4.
