Water Quality Assessment of Sasthamcotta Lake, Kollam, Kerala

Divya Raj S, K Mophin Kani

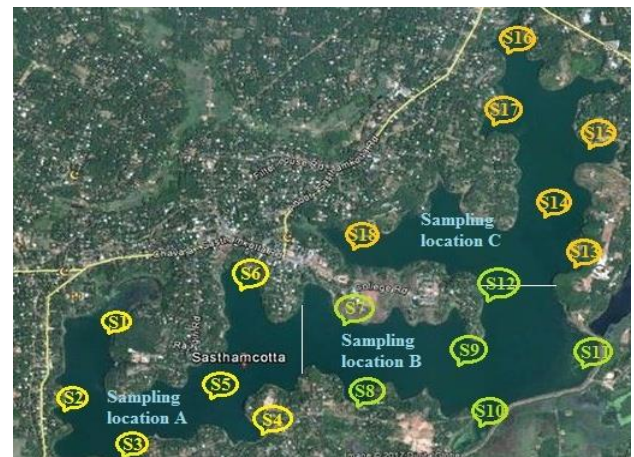
Fig 2: Sampling Points: Surface
(Source: google2.jpg.image.784.410.jpg)

points, onsite activities like huge gathering, agricultural, livestock and laundry activities, six different sampling points were selected within each location as shown in figure 2. Depth wise sampling is also carried out as shown in figure 3. The specific activities at selected sampling points are given in table 1. Water samples were collected during second week of each month (November 2017 to February 2018). Sampling, preservation, and assessment of the water quality were carried out as per standard methods [23].
