Vibration of Tayan Bridge's Hanger in West Kalimantan, Indonesia

Made Suangga, Prasetyo Eko Junianto

Abstract: In November 2015, vibration has been detected at hangers of Tayan steel arch bridge just before its opening for public. The vibrations occurred at certain wind speed in the first asymmetric torsional mode. Vibration on the hanger is a phenomenon that often occurs especially if the hanger is I-shaped. There are 3 possible reason of the vibration including Vortex Induced Vibration (VIV), Galloping and Flutter.

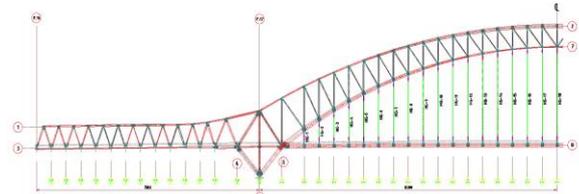
Figure 2. Hanger of Tayan Steel Arch Bridge

The Tayan Bridge is located 112 km from the city of Pontianak, on the South Link of Kalimantan, which connects West Kalimantan and Central Kalimantan Provinces. The total length of the bridge is 1,420 m with 11 m width. The approach bridge consists of a simple composite steel girder bridges with a span of 40 m. The main bridge is steel arch bridge with the main span of 200 m and vertical clearance of 13 m. The full shoring method was adopted for construction of the main bridge. The Tayan Steel Arch Bridge has 35 hangers at one side with the length varies from 0.90 m to 26.80 m as shown in figure 2. The shape of the hanger is Web Flange (WF) with size of 450x150x12x15.

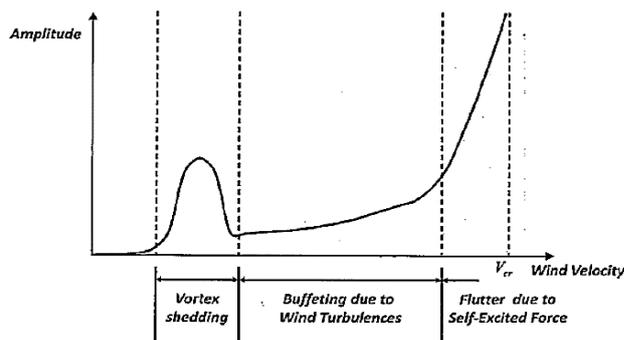
Figure 4. Vortex Induced Vibration and Flutter Instability

(a) Vortex Induced Vibrations (VIV) (b) Flutter Instability

Vortex Induced Vibrations (VIV) only occurs at a certain wind speed and as the wind speed increase, the vibrations that occur will disappear, while the phenomenon of flutter occurs at high speeds speed, the greater the wind speed, the occurring vibration will also increase.

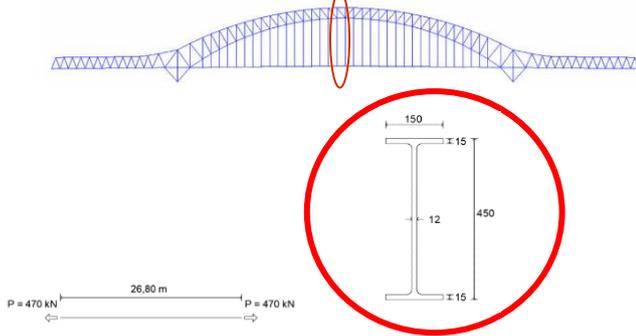
Figure 5. Parameter of Hanger no 18.

The natural frequency of the hanger is calculated for hanger no 18 as shown in figure 4. The length of the hanger is 26.8 m with tension force of 470 kN. Several formulas have been introduced to calculate the natural frequency of the hanger. However, one of the limitations of the formulas that calculates the torsional frequency is that the formulas do not take the effect of the tension load into account.

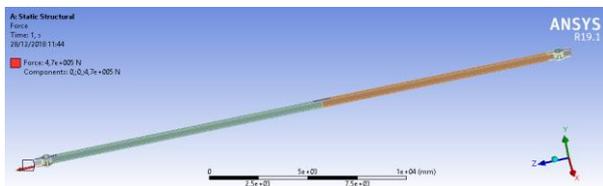
Figure 6. Hanger Modelling

By using ANSYS software, the natural frequency of the hanger can be calculated by taking into account the axial load on the hanger. The finite element model of the hanger is presented in figure 6. The result of natural frequency analysis is presented in table 1.

Mode	Mode Shape	Natural Frequency (Hz)
1	1 st Bending (x-dir)	1,5657
2	1 st Bending (y-dir)	3,2237
3	1 st Torsion	3,2361
4	2 nd Bending (x-dir)	3,3887
5	3 rd Bending (x-dir)	5,5142
6	2 nd Torsion	7,2631

From table 1, it is found that the natural frequency of the hanger for the second torsional mode is 7.2631 Hz. This natural frequency value is similar with the frequency of vortex shedding calculated using equation 1, where N_u is 7.12 Hz.

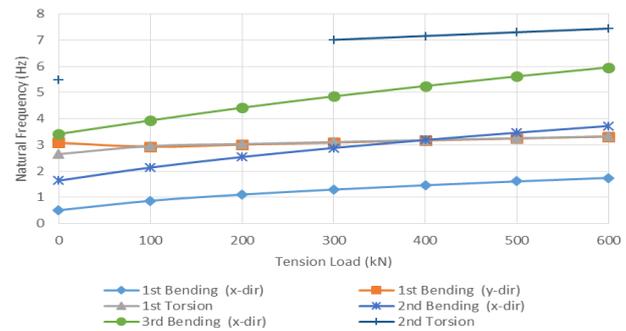
Figure 7. Effect of tension load to natural frequency of hanger

To investigate the effect of tension load to the natural frequency of the hanger, hanger no 18 was analyzed and various tension loads were applied to the hanger. The result of analysis conducted by using ANSYS software is presented in table 2 and figure 7.

From the results, it can be concluded that, the natural frequency of the hanger will increase as the tension load increases, except for the 1st torsional mode. The natural frequency value for 1st torsional mode was relatively constant.

This could explain why the hangers in front of the parked truck did not vibrate, while the other hangers did.

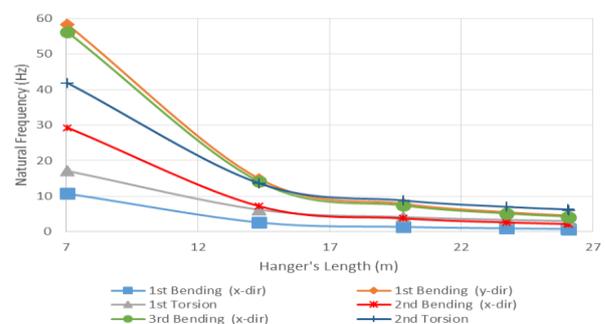
Figure 7. The Effect of Hanger's Length to the Natural Frequency of Hanger

To investigate the effect of hanger's length to the natural frequency of the hanger, the cross section of Tayan bridge's hanger, Web Flange (WF) with size of 450x150x12x15, was analyzed with various hanger's length. The result of analysis using ANSYS software is presented in table 3 and figure 7.

From the results, it can be concluded that, for the hanger that has a length of 19.8 m or more, the natural frequency of the hanger did not varies much.

This could explain why the vibration occur only at several hangers.

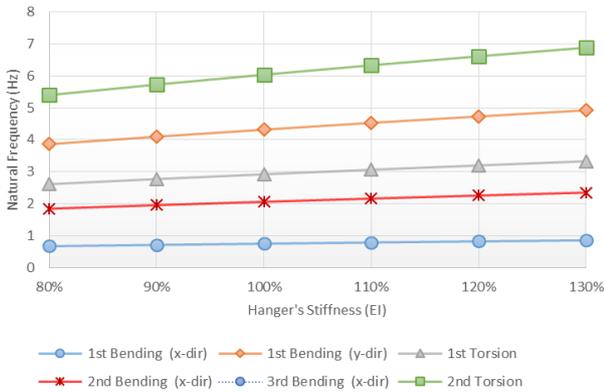
Figure 8. The Effect of Hanger's Stiffness to the Natural Frequency of Hanger

To investigate the effect of hanger's stiffness to the natural frequency of the hanger, hanger no 18 was analyzed and various EI values were applied to the hanger. The result of analysis using ANSYS software is presented in table 4 and figure 8.

From the results, it can be concluded that, the natural frequency of the hanger will increase as the hanger's stiffness increases by an almost similar increment.

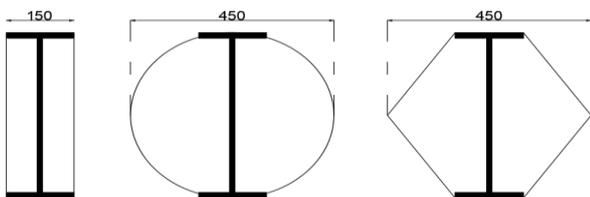
Figure 9. Modification of hanger's shape

Modification of hanger's shape can be done by adding a non- structural material to transform the hanger's shape from I-shape into rectangular, circle and hexagonal shapes, as seen in figure 9.

No	Hanger's Shape	Strouhal Number (S _v)	Hanger dimension perpendicular to wind flow (L _v) m	Vortex shedding wind speed (m/s)
1	Rectangular	0.16	0.15	6.675
2	Circle	0.2	0.45	16.02
3	Hexagonal	0.16	0.45	20.025

It can be concluded that changing the hanger's shape from I-shape to rectangular shape does not improve the performance of the hanger to the vortex induced vibration, while changing the hanger's shape to circle and hexagonal shapes could significantly improve to the vortex induced vibration wind speed.

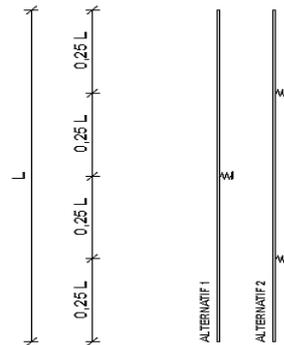
Figure 10. Modification of hanger's stiffness using cable struts

Hanger stiffness was increased by installing cable struts connecting hangers so that the hanger's stiffness can increase. Two struts arrangements were considered, single struts at the middle of hanger's length and double struts at 0.25L and 0.75 L of hanger's length as shown in figure 10.

The stiffness of the cable struts was calculated using the following equation:

$$K_{strut} = \frac{E_{strut} A_{strut}}{L_{strut}} \tag{3}$$

Where the Modulus of Elasticity of cable strut, $E_{strut} = 199.950 \text{ MPa}$; The length of cable strut is equal to the distance between hangers $L_{strut} = 5 \text{ m}$, the diameter of the cable strut, $\Phi_{strut} = 0,6 \text{ in}$ and the section area of the cable struts, $A_{strut} = 0,0001387 \text{ m}^2$.

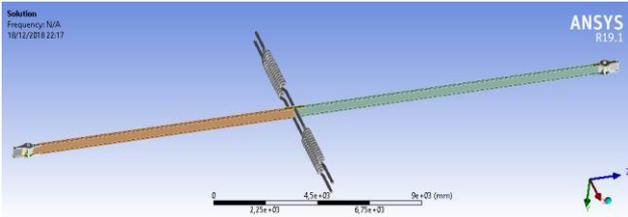
Figure 11. Modelling of Hanger with single strut

The cable strut was modelled as a spring. By using ANSYS software, the natural frequency of the hanger can be calculated by taking into account the axial load on the hanger. The finite element model of the hanger is presented in figure 11 and figure 12. The result of natural frequency analysis is presented in table 6.

From the calculation, it can be concluded that, the natural frequency of the hanger will significantly increase as the number of struts installed increases.

Mode Shape	Natural Frequency (Hz)		
	No cable strut	1 cable strut	2 cable struts
1 st Bending (x-dir)	1.565	3.013	16.258
1 st Bending (y-dir)	3.223	3.238	20.218
1 st Torsion	3.236	6.931	38.228
2 nd Bending (x-dir)	3.388	4.647	28.278
3 rd Bending (x-dir)	5.514	7.267	42.618
2 nd Torsion	7.263	8.580	142.600
